GOVERNMENT OF NEWFOUNDLAND AND LABRADOR Department of Transportation and Infrastructure	BRIDGE INSPECTION REPORT B08062021-4	
Date: 8/3/2021	Inspected By: Mike Button	Category: Office - Bridge Office	
BRIDGE INFORMATION			
Site:	1-342 - COCHRANE POND BROOK BRIDGE SERVICE ROAD		
Route:	3	Overall Length:	24.7 m
Year Built:	1999	Est: No	Overall Width: 5 m
Year Last Rehab.:		Est: No	Roadway Width: 4.2 m
Region:	AVALON PENINSULA	Sidewalk Width:	0 m
Jurisdiction:	Provincial	Clearance to R.D. or N.W.L.:	2.5 m
Type of Structure:	08 - Steel Bridge	Max Depth of N.W.L.:	0.6 m
Purpose of Structure:	04 - Over Non-Navigable Waters	Spans:	
Type of Handrail:	06 - None	<u>Span No.:</u>	<u>Length</u>
Roadway Surface:	03 - Timber	1	18.3
Alignment Vertical:	01 - Good	2	0
Alignment Horizontal:	01 - Good	3	0
Restrictions:	No	6	0
BRIDGE PHOTOS

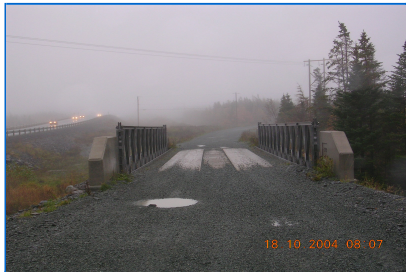
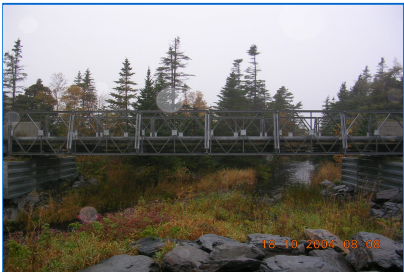
Comments:	- Abutments not overly visible. (mostly buried) What can be seen is in good condition (F2). There are a lot of road gravels, vegetation, and algae covering the bearing area (P1). - Retaining walls in good		
SUPERSTRUCTURE			
Condition:	F2 - Fair	Expansion Joints:	I - Inapplicable
Comments:	- Girder cross bracing under deck for lateral support are loose. Not concerning as these should be or not required to be tight. However, bolts should be tightened before they back off (P3). All girders, and stringers in excellent condition.		
DECK			
Condition:	F1 - Fair	Curbs:	I - Inapplicable

Hand Rail:	P1 - Poor	Roadway Condition:	I - Inapplicable
Approach Rail:	U - Uninspectable		
Comments:	- 3 hazard markers missing (P1). - No approach rails from either side. This is a slow speed gravel road. Are they even required? (P1). Main deck in excellent condition (F2). Wearing timbers (Direction of traffic) look to be fairly new as well (F2). - End blocks are in good condition.		
HYDROLOGY			
Water Velocity:	1.0 m/s	Ice Problem:	N - No Problem
Water Depth:	0.2 m	Scour Problem:	N - No Problem
Waterway:	01 - Adequate	Debris Problem:	N - No Problem
Comments:	Water in center of span. Vegetation growing between river and retaining walls.		
REPLACEMENT/REHABILITATION			
Next Rehab. Date:	2021	Replacement Year:	2060
Antic. Rehab. Cost:	\$5000	Replacement Cost:	\$1000000
Recommendations:	- Install hazard markers. - Tighten loose bolts under deck. - Remove road gravels/vegetation from bearing areas.		
OBSERVATIONS
