GOVERNMENT OF NEWFOUNDLAND AND LABRADOR Department of Transportation and Infrastructure	BRIDGE INSPECTION REPORT B08062021-5	
Date: 8/3/2021	Inspected By: Mike Button	Category: Office - Bridge Office	
BRIDGE INFORMATION			
Site:	1-340 - COCHRANE POND ROAD UNDERPASS		
Route:	3	Overall Length:	24.2 m
Year Built:	2000	Est: No	Overall Width: 6.6 m
Year Last Rehab.:		Est: No	Roadway Width: 5 m
Region:	AVALON PENINSULA		Sidewalk Width: 0 m
Jurisdiction:	Provincial		Clearance to R.D. or N.W.L.: 5.3 m
Type of Structure:	08 - Steel Bridge		Max Depth of N.W.L.: 0 m
Purpose of Structure:	01 - Highway Grade Separation		Spans:
Type of Handrail:	06 - None		<u>Span No.:</u> <u>Length</u> <u>Span No.:</u> <u>Length</u>
Roadway Surface:	03 - Timber	1	21.1 4 0
Alignment Vertical:	01 - Good	2	0 5 0
Alignment Horizontal:	01 - Good	3	0 6 0
Restrictions:	Yes		
Describe Restrictions:	1 Lane Traffic.		
BRIDGE PHOTOS

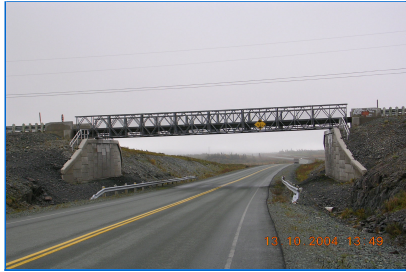
SUBSTRUCTURE			
Condition:	P3 - Poor	Bearings:	U - Uninspectable
		Bearing Seat:	U - Uninspectable
Comments:	- Whole bearing area needs to be cleaned of road gravels and vegetation. Most of bearing area could not be seen and therefore, was not inspected. The concrete in its vicinity was in great condition. - East abutment on roadway needs repair. Concrete disintegrated with top mat of rebar showing (P3). With this exception abutment, F2.		
SUPERSTRUCTURE			
Condition:	P3 - Poor	Expansion Joints:	I - Inapplicable
Comments:	- No exp joints. All pins starting to rust should be galvanized (F1). All beams/welds/bolts in excellent condition (F2). North side, mid-span, bottom chord is damaged (bent/impacted). Likely caused during construction (P3).		
DECK			
Condition:	F1 - Fair	Curbs:	I - Inapplicable

Hand Rail:	F2 - Fair	Roadway Condition:	I - Inapplicable
Approach Rail:	P1 - Poor		
Comments:	- Approach rail needs to be replaced (coming from goulds). Heavily damaged from a collision. Hazard markers missing. - Timber deck wearing surface (direction of traffic) is in poor condition. Main timber decking in F1 condition. - No handrail as such, chain link placed on trusses.

Next Rehab. Date:	2021	Replacement Year:	2070
Antic. Rehab. Cost:	\$50000	Replacement Cost:	\$1000000
Recommendations:	- Replace pins as per note. - Repair east abutment approach concrete. - Replace wearing surface timbers. - Clean bearing areas. - Replace damaged bottom chord. - Exit rails need a 6x6" timber shim to fix the guard rail. - Replace approach guard rail coming from Goulds.
