GOVERNMENT OF NEWFOUNDLAND AND LABRADOR Department of Transportation and Infrastructure	BRIDGE INSPECTION REPORT B09142021-10	
Date: 2/25/2020	Inspected By: Hunt R	Category: Eng. - Engineering	
BRIDGE INFORMATION			
Site:	1-063 - COOTE'S POND BRIDGE NO.1		
Route:		Overall Length:	17.5 m
Year Built:	1968	Est: No	Overall Width: 10.9 m
Year Last Rehab.:		Est: No	Roadway Width: 7.9 m
Region:	AVALON PENINSULA	Sidewalk Width:	1.5 m
Jurisdiction:	Provincial	Clearance to R.D. or N.W.L.:	1.6 m
Type of Structure:	02 - Double Tee	Max Depth of N.W.L.:	0.3 m
Purpose of Structure:	04 - Over Non-Navigable Waters		Spans:
Type of Handrail:	02 - Concrete Rail		<u>Span No.:</u> <u>Length</u> <u>Span No.:</u> <u>Length</u>
Roadway Surface:	02 - Asphalt	1	8.7 4 0
Alignment Vertical:	01 - Good	2	0 5 0
Alignment Horizontal:	01 - Good	3	0 6 0
Restrictions:	No		
BRIDGE PHOTOS

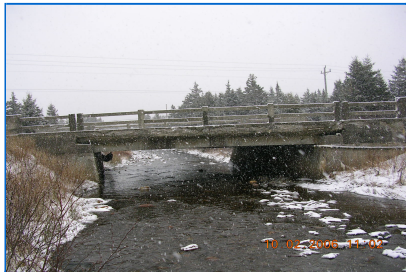
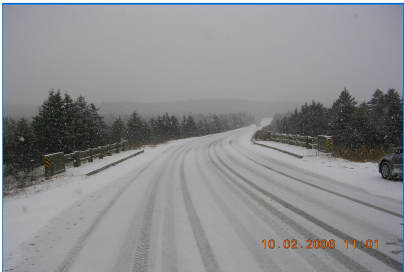
Bearing Seat:	P3 - Poor
Comments:	- Assumed condition of buried and submerged reinforced concrete abutment footings. - Severe delamin./ spalling continues to outside faces and ends of four wingwalls. (A.A.R). - Medium/severe delamin./ spalling with medium efflor. deposits to corners of abutments.		
SUPERSTRUCTURE			
Condition:	P3 - Poor	Expansion Joints:	I - Inapplicable
Comments:	- Medium/severe delamin./ spalling with medium/severe corrosion to exposed reinf. on majority of all tees. - Wide long cracks and severe spalling to interior tee with stressing cable exposed. - Medium/ severe delamin./ spalling to tees directly below deck drain on NE corner of structure. - No visible signs of expansion joints. No chalking in curb sidewalk gaps.		
DECK

Condition:	P3 - Poor	Curbs:	P3 - Poor
Hand Rail:	P1 - Poor	Roadway Condition:	P3 - Poor
Approach Rail:	G - Good		
Comments:	- Deck has been resurfaced and new approach and exit rail installed. No regulation hazard markers up - Very severe delamin./ spalling with medium corrosion to exposed reinf. to deck/ curb fascias. Narrow med. cracks and light spalling to end blocks - Wide horizontal cracks in interior curb/sidewalk fascias. Sections of concrete handrails missing exposing lightly corroded rebar

Next Rehab. Date:	2021	Replacement Year:	2025
Antic. Rehab. Cost:	\$180	Replacement Cost:	\$650
Recommendations:	- Repair all conc. defects on tees, abutments, fascias, wingwalls - Repair or replace conc. handrails
