GOVERNMENT OF NEWFOUNDLAND AND LABRADOR Department of Transportation and Infrastructure	BRIDGE INSPECTION REPORT B09032021-1	
Date: 3/12/2020	Inspected By: Hunt R	Category: Eng. - Engineering	
BRIDGE INFORMATION			
Site:	1-362 - DUMP ROAD UNDERPASS - ARGENTIA		
Route:	100	Overall Length:	35.1 m
Year Built:	1965	Est: Yes	Overall Width: 15.15 m
Year Last Rehab.:		Est: No	Roadway Width: 13.45 m
Region:	AVALON PENINSULA	Sidewalk Width:	0.85 m
Jurisdiction:	Provincial	Clearance to R.D. or N.W.L.:	5 m
Type of Structure:	03 - Reinforced Concrete Beam/Slab	Max Depth of N.W.L.:	0 m
Purpose of Structure:	01 - Highway Grade Separation	Spans:	
Type of Handrail:	02 - Concrete Rail	<u>Span No.:</u>	<u>Length</u>
Roadway Surface:	02 - Asphalt	1	8.6
Alignment Vertical:	01 - Good	2	14
Alignment Horizontal:	02 - Adequate	3	8.6
Restrictions:	No	6	0
			0
BRIDGE PHOTOS

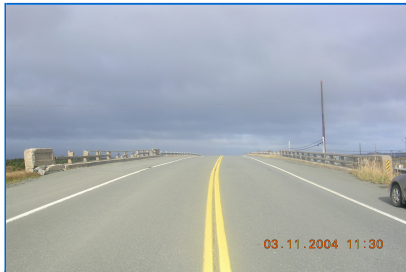
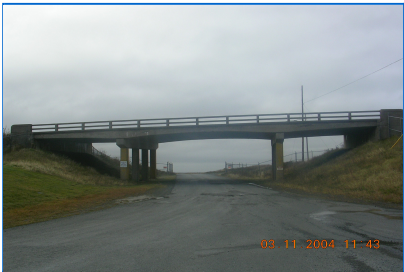
Bearing Seat:	F1 - Fair
Comments:	- Assumed condition of buried reinf. conc. abut. and pier footings - Top north abut. footing partially exposed. - Numerous narrow/wide, horiz./vert. cracks in faces of abutments and wingwalls. - Narrow horiz./vert. cracks in pier caps. - Medium delamin./spalling with medium rusting to exposed reinf. on bottom of pier caps. -medium delamin./spalling/disintegration with medium rusting to exposed reinf. at SE abut. corner. - Asphalt and foam bearings continue to age and break down		
SUPERSTRUCTURE			
Condition:	F1 - Fair	Expansion Joints:	F1 - Fair
Comments:	- Hairline alligator cracks in 4 end blocks. - Asphalt impregnated board exp. joints - Gaps in curbs & sidewalks beginning to wear		
DECK

Condition:	F1 - Fair	Curbs:	F2 - Fair
Hand Rail:	F2 - Fair	Roadway Condition:	F2 - Fair
Approach Rail:	F2 - Fair		
Comments:	- No north hazard markers (posts still in place). - Medium delamin./spalling/disintegration with medium rusting to exposed reinf. to SE end of deck soffit. - Medium spalling to east edge of deck soffit (north span). - Numerous light rust stains on deck soffit. - Medium trans./vert. cracks in curb surfaces and fascia. - Wide horiz. cracks in deck fascia. - Wide long. cracks with medium efflor./stalactite deposits along center of deck soffits at south and center spans. - Asphalt spacing off on south approach slab

Water Velocity:	n/a m/s	Ice Problem:	NA - Not Applicable
Water Depth:	n/a m	Scour Problem:	NA - Not Applicable
Waterway:	03 - Not Applicable	Debris Problem:	NA - Not Applicable
Comments:	- Medium shoulder/asphalt erosion at corners of structure. - Medium trans. cracks in asphalt at exp. joint locations. Asphalt spalling off on south app. slab. - Structure has been struck underneath (center span, east side).

Next Rehab. Date:	2022	Replacement Year:	2030
Antic. Rehab. Cost:	\$80	Replacement Cost:	\$2500
Recommendations:	- Repair all concrete defects in pier caps and deck soffit. Correct erosion at shoulders/corners. - Monitor exp. joints/bearings. - Install north hazard markers (maint).
