GOVERNMENT OF NEWFOUNDLAND AND LABRADOR Department of Transportation and Infrastructure	<b>BRIDGE INSPECTION REPORT</b> <b>B09212021-1</b>	
<b>Date:</b> 5/12/2020	<b>Inspected By:</b> Hunt R	<b>Category:</b> Eng. - Engineering	
<b>BRIDGE INFORMATION</b>			
<b>Site:</b>	1-156 - FOREST POND BRIDGE		
<b>Route:</b>		<b>Overall Length:</b>	25.2 m
<b>Year Built:</b>	1960	<b>Est: No</b>	<b>Overall Width:</b> 10.1 m
<b>Year Last Rehab.:</b>		<b>Est: No</b>	<b>Roadway Width:</b> 7 m
<b>Region:</b>	AVALON PENINSULA	<b>Sidewalk Width:</b>	0 m
<b>Jurisdiction:</b>	Provincial	<b>Clearance to R.D. or N.W.L.:</b>	2.5 m
<b>Type of Structure:</b>	01 - AASH to Girder	<b>Max Depth of N.W.L.:</b>	1 m
<b>Purpose of Structure:</b>	04 - Over Non-Navigable Waters	<b>Spans:</b>	
<b>Type of Handrail:</b>	01 - Aluminum Rail	<u>Span No.:</u>	<u>Length</u>
<b>Roadway Surface:</b>	02 - Asphalt	1	15
<b>Alignment Vertical:</b>	01 - Good	2	0

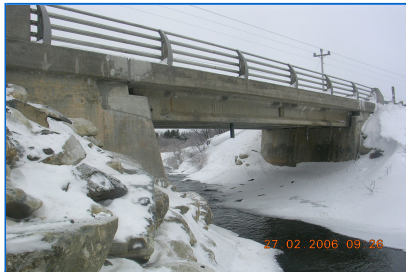
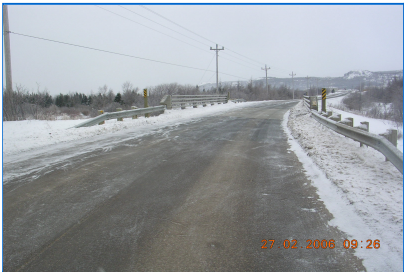
<b>SUBSTRUCTURE</b>			
<b>Condition:</b>	F2 - Fair	<b>Bearings:</b>	F2 - Fair
		<b>Bearing Seat:</b>	F2 - Fair
<b>Comments:</b>	- Narrow vertical cracks and light erosion along faces of abutment footings - Narrow vertical cracks in abutment faces - Narrow horizontal/vertical/alligator cracks with light/med efflor. deposits in 4 wingwalls		
<b>SUPERSTRUCTURE</b>			
<b>Condition:</b>	F2 - Fair	<b>Expansion Joints:</b>	F1 - Fair
<b>Comments:</b>	- Medium transverse cracks and medium spalling/disintegration to expansion joint dams - Narrow longit. cracks along top and bottom flanges of most girders		
<b>DECK</b>			
<b>Condition:</b>	F2 - Fair	<b>Curbs:</b>	P1 - Poor

<b>Hand Rail:</b>	P3 - Poor	<b>Roadway Condition:</b>	P1 - Poor
<b>Approach Rail:</b>	F2 - Fair		
<b>Comments:</b>	- Medium spalling and marrow transverse cracks in exposed deck surfaces - Medium/wide horizontal vertical cracks with moderate/severe spalling/disintegration to D/S curbs and fascias. U/S curb and fascias not quite as bad - Fascias at exp. joint locations have large cracks and spalling concrete -D/S end blocks have large cracks and severe deterioration. Alum. handrail has some moderate damage with scrapes and dents and end caps missing

<b>Overall Condition:</b>	P1 - Poor	<b>Requires Further Inspection:</b>	No
<b>Additional Observations:</b>	P1 - D/S deck curbs and fascias and end blocks F1 - remainder of U/S deck curb fascias and endblocks, alum. handrail F2 - remainder

<b>Next Rehab. Date:</b>	2021	<b>Replacement Year:</b>	2040
<b>Antic. Rehab. Cost:</b>	\$130	<b>Replacement Cost:</b>	\$1600
<b>Recommendations:</b>	- Repair all concrete defects, especially deck/curb surfaces and fascias - Replace exp. joint dams and joints and put in new end blocks - Repair alum. handrail or replace with steel rail system - In the interm. install regulation hazard markers and clean out exp. joints
