GOVERNMENT OF NEWFOUNDLAND AND LABRADOR Department of Transportation and Infrastructure	BRIDGE INSPECTION REPORT B10272015-4	
Date: 10/25/2015	Inspected By: Rodger Hussey	Category: Eng. - Engineering	
BRIDGE INFORMATION			
Site:	1-355 - GOLDSTONE ST. BIFUR. RD. OVERPASS NORTH		
Route:		Overall Length:	53.1 m
Year Built:	2002	Est: No	Overall Width: 13.06 m
Year Last Rehab.:		Est: No	Roadway Width: 12.13 m
Region:	AVALON PENINSULA	Sidewalk Width:	0 m
Jurisdiction:	Provincial	Clearance to R.D. or N.W.L.:	0 m
Type of Structure:	05 - Pre-stressed Concrete Slab	Max Depth of N.W.L.:	0 m
Purpose of Structure:	01 - Highway Grade Separation	Spans:	
Type of Handrail:	05 - Concrete Barrier	<u>Span No.:</u>	<u>Length</u>
Roadway Surface:	02 - Asphalt	<u>Span No.:</u>	<u>Length</u>
Alignment Vertical:	01 - Good	1	11.15
Alignment Horizontal:	01 - Good	2	22.3
Restrictions:	No	3	11.15
		4	0
		5	0
		6	0
BRIDGE PHOTOS

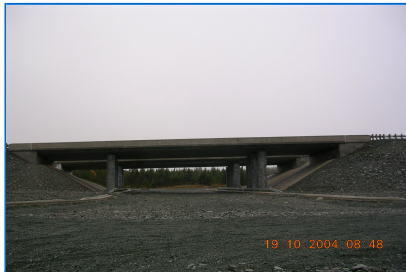
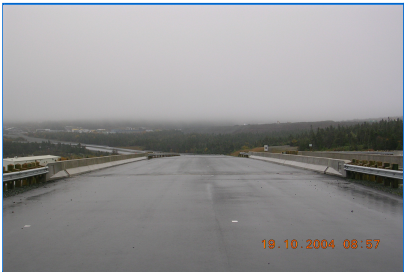
SUBSTRUCTURE			
Condition:	G - Good	Bearings:	G - Good
		Bearing Seat:	G - Good
Comments:			
SUPERSTRUCTURE			
Condition:	G - Good	Expansion Joints:	F2 - Fair
Comments:	Expansion joint leaking on one side.		
DECK			
Condition:	G - Good	Curbs:	I - Inapplicable
Hand Rail:	G - Good	Roadway Condition:	I - Inapplicable

Approach Rail:	G - Good		
Comments:	Reflective cracking on roadway at beginning of approach slab; Jersey barrier hand rails, no curbs.		
HYDROLOGY			
Water Velocity:	0 m/s	Ice Problem:	NA - Not Applicable
Water Depth:	0 m	Scour Problem:	NA - Not Applicable
Waterway:	03 - Not Applicable	Debris Problem:	NA - Not Applicable
Comments:			
REPLACEMENT/REHABILITATION			
Next Rehab. Date:	2015	Replacement Year:	2015
Antic. Rehab. Cost:	\$0	Replacement Cost:	\$0
Recommendations:			
OBSERVATIONS			
Overall Condition:	G - Good	Requires Further Inspection:	No
Additional Observations:			
LEGEND:			
Condition Definitions:			
1 - *Good - [discontinued code].	F2 - Fair.	C - Unsafe (Closed to Public).	Problem Definitions:
2 - *Fair - [discontinued code].	F1 - Fair.	U - Uninspectable.	N - No Problem.
3 - *Poor - [discontinued code].	P3 - Poor.	I - Inapplicable.	P - Possible Problem.
4 - *Unsafe - [discontinued code].	P1 - Poor.		K - Known Problem.
