GOVERNMENT OF NEWFOUNDLAND AND LABRADOR Department of Transportation and Infrastructure	BRIDGE INSPECTION REPORT B10272015-5	
Date: 10/25/2015	Inspected By: Rodger Hussey	Category: Eng. - Engineering	
BRIDGE INFORMATION			
Site:	1-357 - GOLDSTONE ST. BIFUR. RD. OVERPASS SOUTH		
Route:		Overall Length:	53.1 m
Year Built:	2002	Est: No	Overall Width: 13.06 m
Year Last Rehab.:		Est: No	Roadway Width: 12.16 m
Region:	AVALON PENINSULA	Sidewalk Width:	0 m
Jurisdiction:	Provincial	Clearance to R.D. or N.W.L.:	0 m
Type of Structure:	05 - Pre-stressed Concrete Slab	Max Depth of N.W.L.:	0 m
Purpose of Structure:	01 - Highway Grade Separation	Spans:	
Type of Handrail:	05 - Concrete Barrier	<u>Span No.:</u>	<u>Length</u>
Roadway Surface:	02 - Asphalt	<u>Span No.:</u>	<u>Length</u>
Alignment Vertical:	01 - Good	1	11.15
Alignment Horizontal:	01 - Good	2	22.3
Restrictions:	No	3	11.15
		4	0
		5	0
		6	0
BRIDGE PHOTOS

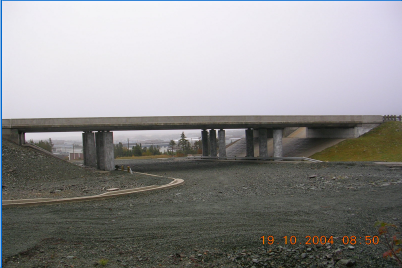
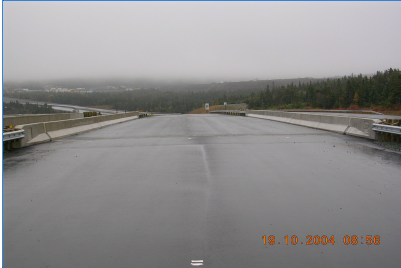
SUBSTRUCTURE			
Condition:	G - Good	Bearings:	G - Good
		Bearing Seat:	F2 - Fair
Comments:			
SUPERSTRUCTURE			
Condition:	G - Good	Expansion Joints:	F2 - Fair
Comments:	Expansion joint leaking on one side, minor.		
DECK			
Condition:	F2 - Fair	Curbs:	I - Inapplicable
Hand Rail:	G - Good	Roadway Condition:	I - Inapplicable

Approach Rail:	P3 - Poor		
Comments:	Jersey barrier hand rails, no curbs; Minor damage to approach rail on one side, guide rail tipping out, end posts have become detached (4); Reflective cracking of asphalt at beginning of approach slab.		
HYDROLOGY			
Water Velocity:	0 m/s	Ice Problem:	NA - Not Applicable
Water Depth:	0 m	Scour Problem:	NA - Not Applicable
Waterway:	03 - Not Applicable	Debris Problem:	NA - Not Applicable
Comments:			
REPLACEMENT/REHABILITATION			
Next Rehab. Date:	2015	Replacement Year:	2015
Antic. Rehab. Cost:	\$0	Replacement Cost:	\$0
Recommendations:	Repair approach rail.		
OBSERVATIONS			
Overall Condition:	G - Good	Requires Further Inspection:	No
Additional Observations:			
LEGEND:			
Condition Definitions:		Problem Definitions:	
1 - *Good - [discontinued code].	F2 - Fair.	C - Unsafe (Closed to Public).	N - No Problem.
2 - *Fair - [discontinued code].	F1 - Fair.	U - Uninspectable.	P - Possible Problem.
