GOVERNMENT OF NEWFOUNDLAND AND LABRADOR Department of Transportation and Infrastructure	<b>BRIDGE INSPECTION REPORT</b> <b>B06112019-1</b>	
<b>Date:</b> 1/17/2019	<b>Inspected By:</b> Hunt R	<b>Category:</b> Eng. - Engineering	
<b>BRIDGE INFORMATION</b>			
<b>Site:</b>	1-152 - GOSSE'S BRIDGE, ISLAND POND BROOK		
<b>Route:</b>	20	<b>Overall Length:</b>	14 m
<b>Year Built:</b>	1986	<b>Est: No</b>	<b>Overall Width:</b> 17.2 m
<b>Year Last Rehab.:</b>		<b>Est: No</b>	<b>Roadway Width:</b> 12.5 m
<b>Region:</b>	AVALON PENINSULA	<b>Sidewalk Width:</b>	2 m
<b>Jurisdiction:</b>	Provincial	<b>Clearance to R.D. or N.W.L.:</b>	1.5 m
<b>Type of Structure:</b>	03 - Reinforced Concrete Beam/Slab	<b>Max Depth of N.W.L.:</b>	0.3 m
<b>Purpose of Structure:</b>	04 - Over Non-Navigable Waters	<b>Spans:</b>	
<b>Type of Handrail:</b>	01 - Aluminum Rail	<b>Span No.:</b>	<b>Length</b>
<b>Roadway Surface:</b>	02 - Asphalt	1	10.1

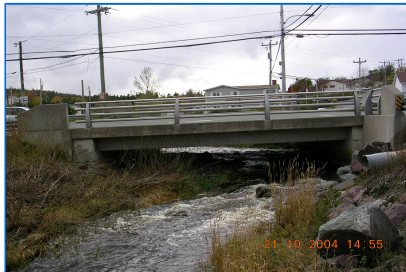
<b>SUBSTRUCTURE</b>			
<b>Condition:</b>	F2 - Fair	<b>Bearings:</b>	F2 - Fair
		<b>Bearing Seat:</b>	F2 - Fair
<b>Comments:</b>	Assumed condition of buried submerged reinforcement concrete abutment footings. Narrow vertical horizontal cracks in abutment faces. Concrete spalling at South East wingwall at expansion gap. Wide vertical crack at South East wingwall near abutment cover. Medium erosion and narrow alligator cracking on face of north abutment.		
<b>SUPERSTRUCTURE</b>			
<b>Condition:</b>	F2 - Fair	<b>Expansion Joints:</b>	F2 - Fair
<b>Comments:</b>	Narrow vertical/angular cracks in al beams. Medium/wide alligator cracks in all four end blocks.		
<b>DECK</b>			
<b>Condition:</b>	F2 - Fair	<b>Curbs:</b>	F2 - Fair

<b>Hand Rail:</b>	F2 - Fair	<b>Roadway Condition:</b>	F2 - Fair
<b>Approach Rail:</b>	F2 - Fair		
<b>Comments:</b>	Narrow transverse cracks with light efflor deposits in deck soffits. Asphalt resurfaces over deck in 2018. Some minor dents and scraps in aluminum handrail. Medium transverse cracks with medium efflor deposits along long construction joint and center of deck soffit. Narrow cracks in deck curbs and soffit.		
<b>HYDROLOGY</b>			
<b>Water Velocity:</b>	0.3 m/s	<b>Ice Problem:</b>	N - No Problem
<b>Water Depth:</b>	0.4 m	<b>Scour Problem:</b>	N - No Problem
<b>Waterway:</b>	01 - Adequate	<b>Debris Problem:</b>	N - No Problem
<b>Comments:</b>	Water currently passing north abutment.		
<b>REPLACEMENT/REHABILITATION</b>			
<b>Next Rehab. Date:</b>	2028	<b>Replacement Year:</b>	2036
<b>Antic. Rehab. Cost:</b>	\$50	<b>Replacement Cost:</b>	\$1200
<b>Recommendations:</b>	Regulator hazard markers should be installed possibly monitor movement at South East expansion joint location.
