GOVERNMENT OF NEWFOUNDLAND AND LABRADOR Department of Transportation and Infrastructure	BRIDGE INSPECTION REPORT B09232021-7	
Date: 1/28/2020	Inspected By: Gillis M	Category: Eng. - Engineering	
BRIDGE INFORMATION			
Site:	1-048 - GULL POND PENSTOCK BRIDGE		
Route:	10	Overall Length:	5.5 m
Year Built:	1970	Overall Width:	31 m
Year Last Rehab.:		Roadway Width:	6.3 m
Region:	AVALON PENINSULA	Sidewalk Width:	0.3 m
Jurisdiction:	Provincial	Clearance to R.D. or N.W.L.:	0.7 m
Type of Structure:	04 - Rigid Frame	Max Depth of N.W.L.:	0 m
Purpose of Structure:	01 - Highway Grade Separation	Spans:	
Type of Handrail:	04 - Steel Rail	<u>Span No.:</u>	<u>Length</u>
Roadway Surface:	02 - Asphalt	1	4.7
Alignment Vertical:	01 - Good	2	0
Alignment Horizontal:	01 - Good	3	0
Restrictions:	No	6	0
BRIDGE PHOTOS

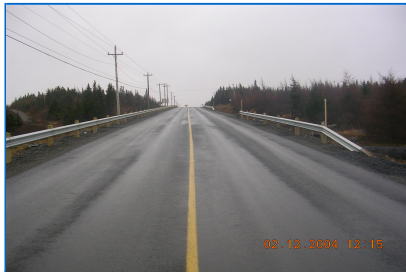
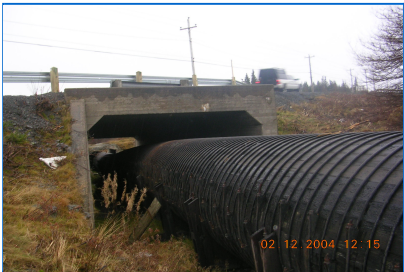
SUBSTRUCTURE			
Condition:	F2 - Fair	Bearings:	I - Inapplicable
		Bearing Seat:	I - Inapplicable
Comments:	- Structure description unchanged from previous inspection. - New penstock backfilled up to 1/2 penstock DIA.

SUPERSTRUCTURE			
Condition:	F2 - Fair	Expansion Joints:	I - Inapplicable
Comments:	- Narrow cracking with light/ medium efflor. deposits in frame legs, wingwalls and deck soffit. - Light spalling and leaking around construction joints.		
DECK			
Condition:	F2 - Fair	Curbs:	I - Inapplicable
Hand Rail:	I - Inapplicable	Roadway Condition:	I - Inapplicable

Approach Rail:	P3 - Poor		
Comments:	- Light/ medium honeycombing with narrow cracking and light efflor. deposits in deck soffit. - Guiderail buried, assume same as 2018 inspection - Guiderail running along Rte. 10 deteriorating with medium damage and cracked and decaying posts. - Minor leaking continues around AIB in const. joints.		
HYDROLOGY			
Water Velocity:	n/a m/s	Ice Problem:	NA - Not Applicable
Water Depth:	n/a m	Scour Problem:	NA - Not Applicable
Waterway:	03 - Not Applicable	Debris Problem:	NA - Not Applicable
Comments:	- Medium bulging and shifting to SE gabion wall atop SW wingwall and deck.		
REPLACEMENT/REHABILITATION			
Next Rehab. Date:	2020	Replacement Year:	2030
Antic. Rehab. Cost:	\$25	Replacement Cost:	\$600
Recommendations:	- Repair all concrete defects. - Repair/ replace guiderail and gabion retaining wall.		
OBSERVATIONS			
Overall Condition:	P3 - Poor	Requires Further Inspection:	No

Additional Observations:	- P3 (guiderail/ gabion wall). - F2 (structure). - 300 mm diameter PVC attached to face of south frame leg - 500 mm diameter PVC inlet at SE corner of structure next to penstock.		
LEGEND:			
Condition Definitions:		Problem Definitions:	
1 - *Good - [discontinued code].	F2 - Fair.	C - Unsafe (Closed to Public).	N - No Problem.
2 - *Fair - [discontinued code].	F1 - Fair.	U - Uninspectable.	P - Possible Problem.
3 - *Poor - [discontinued code].	P3 - Poor.	I - Inapplicable.	K - Known Problem.
4 - *Unsafe - [discontinued code].	P1 - Poor.		NA - Not Applicable.
G - Good.	P - Poor.		
Category Definitions:			
Maint. - Maintenance.			
Eng. - Engineering.			
Office - Bridge Office.			
PHOTO GUIDELINES:			
Inspection Photos:			
Please provide photos using guidelines below:			
<ul style="list-style-type: none"> ● Any item which inspector feels should be documented by photograph ● All items noted above as being P3, P1, P, or C ● Any evidence of known ice, scour, debris, waterway problems
