GOVERNMENT OF NEWFOUNDLAND AND LABRADOR Department of Transportation and Infrastructure	BRIDGE INSPECTION REPORT B06282019-1	
Date: 6/28/2019	Inspected By: lyver C	Category: Eng. - Engineering	
BRIDGE INFORMATION			
Site:	1-331 - HALLSTOWN OVERPASS (CBN)		
Route:	75	Overall Length:	30.5 m
Year Built:	1997	Est: No	Overall Width: 14 m
Year Last Rehab.:		Est: No	Roadway Width: 13.2 m
Region:	AVALON PENINSULA	Sidewalk Width:	0 m
Jurisdiction:	Provincial	Clearance to R.D. or N.W.L.:	4.8 m
Type of Structure:	04 - Rigid Frame	Max Depth of N.W.L.:	0 m
Purpose of Structure:	01 - Highway Grade Separation	Spans:	
Type of Handrail:	05 - Concrete Barrier	Span No.:	Length
Roadway Surface:	02 - Asphalt	1	13
Alignment Vertical:	01 - Good	2	0
Alignment Horizontal:	01 - Good	3	0
Restrictions:	No	Span No.:	Length
		4	0
		5	0
		6	0
BRIDGE PHOTOS

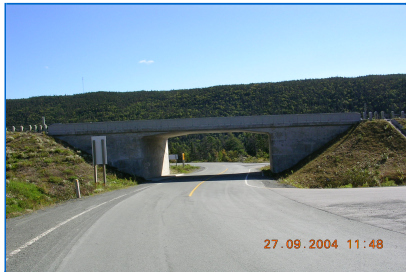
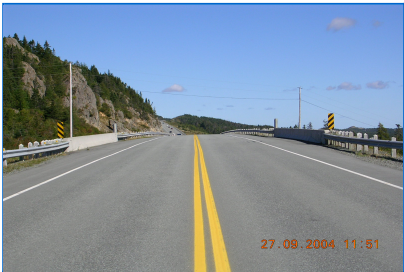
Comments:	Assumed condition of buried reinforcement concrete frame leg footings. Some light spalling with light rusting to exposed reinforcement in frame legs.		
SUPERSTRUCTURE			
Condition:	F2 - Fair	Expansion Joints:	I - Inapplicable
Comments:	Medium vertical cracks in faces of frame legs. Cracks extended up into deck handles. Narrow vertical horizontal alligator cracks in 4 wingwalls.		
DECK			
Condition:	F2 - Fair	Curbs:	F2 - Fair

Hand Rail:	F2 - Fair	Roadway Condition:	F2 - Fair
Approach Rail:	F2 - Fair		
Comments:	Narrow longitudinal cracks with light efflor deposits in deck soffit. Medium vertical cracks and hairline alligator cracks in deck curb fascias. Asphalt on route 75 has rusting and transverse cracks along approach slab. Numerous vertical cracks in concrete barrier walls. Narrow alligator cracking in barrier wall end blocks.		
HYDROLOGY			
Water Velocity:	0 m/s	Ice Problem:	NA - Not Applicable
Water Depth:	0 m	Scour Problem:	NA - Not Applicable
Waterway:	03 - Not Applicable	Debris Problem:	NA - Not Applicable
Comments:	Asphalt on hallstown road in good condition. Hazard markers on left side of route 75 missing.		
REPLACEMENT/REHABILITATION			
Next Rehab. Date:	2022	Replacement Year:	2047
Antic. Rehab. Cost:	\$100	Replacement Cost:	\$1000
Recommendations:	Repair rail, asphalt on route 75 and install missing hazard markers.
