GOVERNMENT OF NEWFOUNDLAND AND LABRADOR Department of Transportation and Infrastructure	BRIDGE INSPECTION REPORT B09132021-8	
Date: 9/13/2021	Inspected By: Gillis M	Category: Eng. - Engineering	
BRIDGE INFORMATION			
Site:	1-117 - HARCOT BROOK BRIDGE		
Route:	93	Overall Length:	27.1 m
Year Built:	1978	Est: Yes	Overall Width: 9.1 m
Year Last Rehab.:		Est: No	Roadway Width: 7.9 m
Region:	AVALON PENINSULA	Sidewalk Width:	0 m
Jurisdiction:	Provincial	Clearance to R.D. or N.W.L.:	1.5 m
Type of Structure:	01 - AASH to Girder	Max Depth of N.W.L.:	1.8 m
Purpose of Structure:	04 - Over Non-Navigable Waters	Spans:	
Type of Handrail:	01 - Aluminum Rail	Span No.:	Length
Roadway Surface:	01 - Concrete	1	14.6
Alignment Vertical:	01 - Good	2	0
Alignment Horizontal:	01 - Good	3	0
Restrictions:	No	Span No.:	Length
		4	0
		5	0
		6	0
BRIDGE PHOTOS

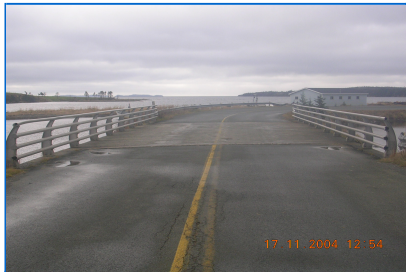
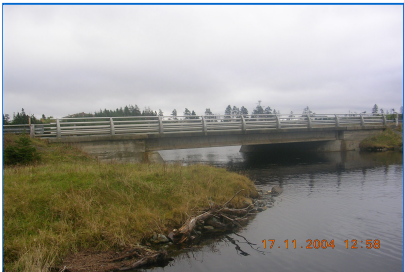
Comments:	- Assumed condition of buried/ submerged reinf. conc. abut. footings. - Light scaling/ delamin. to some bearing seats. - Thick kelp on abut./ wingwall faces up to HWM. - Small medium spalling in face of SW wingwall under exp. joint gap in curb. - Bearing pads crushed in places causing girder ends to contact bearing seats. - Medium/ severe erosion along bottom faces and corners of abutments.		
SUPERSTRUCTURE			
Condition:	F1 - Fair	Expansion Joints:	P1 - Poor
Comments:	- Numerous areas if med. delamin./ spalling with light rusting to exposed reinf. on girders. - Wide vert. cracks in girder ends and end diaphragms. - Exp. joints leaking, seals damaged with sections of striker plates missing. - Numerous long. cracks and severe abrasion to exp. joint dams.		
DECK

Condition:	F1 - Fair	Curbs:	I - Inapplicable
Hand Rail:	P3 - Poor	Roadway Condition:	I - Inapplicable
Approach Rail:	F1 - Fair		
Comments:	- No hazard markers. - Numerous small spalls on exposed deck surface (some patched with asphalt). - Medium/ small potholes in asphalt on approaches. - Medium road settlement at exp. joint dams. - Numerous scrapes, dents, damage and end caps missing on alum. handrails (esp. at ends). - Approach/ exit guiderail aging with minor damage and decaying posts.		
HYDROLOGY			
Water Velocity:	tidal m/s	Ice Problem:	N - No Problem
Water Depth:	tidal m	Scour Problem:	N - No Problem
Waterway:	01 - Adequate	Debris Problem:	N - No Problem
Comments:	- Medium road settlement at exp. joints. - Asphalt ramped up to exp. joint dams - Medium/ severe slope erosion at 4 corners of structure.		
REPLACEMENT/REHABILITATION			
Next Rehab. Date:	2020	Replacement Year:	2030
Antic. Rehab. Cost:	\$150	Replacement Cost:	\$800

Recommendations:	- Repair all concrete defects. - Repair alum. handrails, install end blocks, replace exp. joints, resurface deck, pave approaches. - Install new approach/ exit guiderail. - Place rip-rap at 4 corners of structure and possibly replace some bearing pads. - In the interim, install 4 new regulation size hazard markers (maint).		
OBSERVATIONS			
Overall Condition:	P1 - Poor	Requires Further Inspection:	No
Additional Observations:	- P1 (Expansion joints). - P3 (bearing pads, handrails, surface). - F1 (deck surface, guiderail). - F2 (remainder). - Mostly unchanged from previous inspection.		
LEGEND:			
Condition Definitions:		Problem Definitions:	
1 - *Good - [discontinued code].	F2 - Fair.	C - Unsafe (Closed to Public).	N - No Problem.
2 - *Fair - [discontinued code].	F1 - Fair.	U - Uninspectable.	P - Possible Problem.
3 - *Poor - [discontinued code].	P3 - Poor.	I - Inapplicable.	K - Known Problem.
