GOVERNMENT OF NEWFOUNDLAND AND LABRADOR Department of Transportation and Infrastructure	BRIDGE INSPECTION REPORT B06192019-1	
Date: 6/19/2019	Inspected By: lyver C	Category: Eng. - Engineering	
BRIDGE INFORMATION			
Site:	1-349 - HAT POND BROOK BRIDGE CBN BYPASS		
Route:		Overall Length:	29.3 m
Year Built:	2002	Est: No	Overall Width: 14.1 m
Year Last Rehab.:		Est: No	Roadway Width: 11.2 m
Region:	AVALON PENINSULA	Sidewalk Width:	0 m
Jurisdiction:	Provincial	Clearance to R.D. or N.W.L.:	2.9 m
Type of Structure:	04 - Rigid Frame	Max Depth of N.W.L.:	0.3 m
Purpose of Structure:	04 - Over Non-Navigable Waters	Spans:	
Type of Handrail:	05 - Concrete Barrier	<u>Span No.:</u>	<u>Length</u>
Roadway Surface:	02 - Asphalt	<u>Span No.:</u>	<u>Length</u>
Alignment Vertical:	01 - Good	1	11.3
Alignment Horizontal:	02 - Adequate	2	0
Restrictions:	No	3	0
		4	0
		5	0
		6	0
BRIDGE PHOTOS

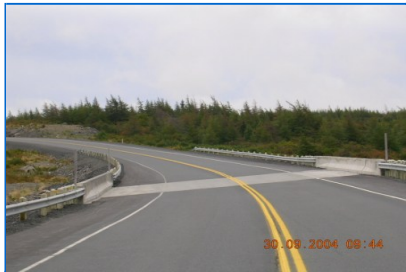
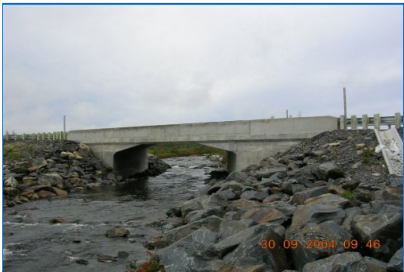
Bearing Seat:	I - Inapplicable
Comments:	Assumed condition of buried/submerged reinforced concrete frame leg footings.		
SUPERSTRUCTURE			
Condition:	F2 - Fair	Expansion Joints:	I - Inapplicable
Comments:	Numerous hairline narrow alligator cracks in 4 wingwalls. Narrow vertical cracks in faces of frame legs cracks extended into deck soffit.		
DECK			
Condition:	F2 - Fair	Curbs:	I - Inapplicable
Hand Rail:	F2 - Fair	Roadway Condition:	I - Inapplicable

Approach Rail:	F2 - Fair		
Comments:	Numerous hairline narrow alligator cracking with light efflor deposits in deck soffit. Medium longitudinal angular cracks in exposed deck surface. Numerous medium vertical cracks in barrier walls, barrier walls end block.		
HYDROLOGY			
Water Velocity:	0.3 m/s	Ice Problem:	N - No Problem
Water Depth:	0.4 m	Scour Problem:	N - No Problem
Waterway:	01 - Adequate	Debris Problem:	N - No Problem
Comments:	Type 3 hyd rip rap at 4 corners of the structure along front of frame legs along river banks remain in fair condition.		
REPLACEMENT/REHABILITATION			
Next Rehab. Date:	2035	Replacement Year:	2077
Antic. Rehab. Cost:	\$100	Replacement Cost:	\$800
Recommendations:	Install missing hazard markers.		
OBSERVATIONS			
Overall Condition:	F2 - Fair	Requires Further Inspection:	No
Additional Observations:	Unchanged from 2011 inspection.		
LEGEND:			
Condition Definitions:		Problem Definitions:
