GOVERNMENT OF NEWFOUNDLAND AND LABRADOR Department of Transportation and Works	BRIDGE INSPECTION REPORT B07112018-5 Printed: Tuesday, October 2, 2018	
Date: 7/10/2018	Inspected By: Parsons R	Category: Maint. - Maintenance	
BRIDGE INFORMATION			
Site:	1-243 - HEART'S DELIGHT BROOK BRIDGE(NORTH)		
Route:		Overall Length:	14.8 m
Year Built:	1965	Est: No	Overall Width: 9.5 m
Year Last Rehab.:		Est: No	Roadway Width: 8.6 m
Region:	AVALON PENINSULA	Sidewalk Width:	0.45 m
Jurisdiction:	Provincial	Clearance to R.D. or N.W.L.:	2 m
Type of Structure:	02 - Double Tee	Max Depth of N.W.L.:	0.4 m
Purpose of Structure:	04 - Over Non-Navigable Waters	Spans:	
Type of Handrail:	01 - Aluminum Rail	<u>Span No.:</u>	<u>Length</u>
Roadway Surface:	02 - Asphalt	<u>Span No.:</u>	<u>Length</u>
Alignment Vertical:	02 - Adequate	1	10.6
Alignment Horizontal:	02 - Adequate	2	0
Restrictions:	No	3	0
		4	0
		5	0
		6	0
BRIDGE PHOTOS

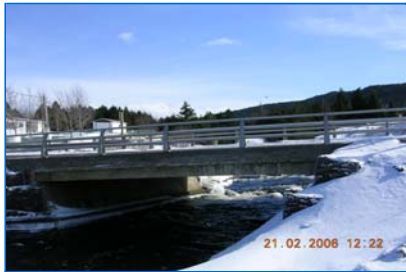
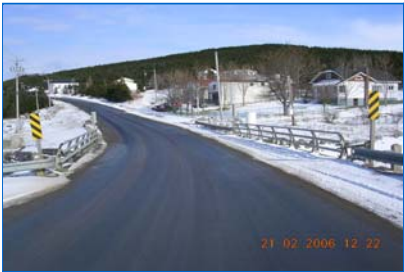
SUBSTRUCTURE			
Condition:	F2 - Fair (Inspection within 2 Years)	Bearings:	G - Good (Inspection within 2 Years)
		Bearing Seat:	G - Good (Inspection within 2 Years)
Comments:	- Deterioration of concrete abutments. - Some scouring.		
SUPERSTRUCTURE			
Condition:	F1 - Fair (Inspection within 1 Year)	Expansion Joints:	U - Uninspectable
Comments:	- Expansion joints paved over. - Rail footings deteriorating.		
DECK			
Condition:	F2 - Fair (Inspection within 2 Years)	Curbs:	F2 - Fair (Inspection within 2 Years)
Hand Rail:	F2 - Fair (Inspection within 2 Years)	Roadway Condition:	F2 - Fair (Inspection within 2 Years)

Approach Rail:	F1 - Fair (Inspection within 1 Year)		
Comments:	- Handrail buckled in places. - North approach handrail needs repair.		
HYDROLOGY			
Water Velocity:	0 m/s	Ice Problem:	N - No Problem
Water Depth:	1 m	Scour Problem:	K - Known Problem
Waterway:	01 - Adequate	Debris Problem:	P - Possible Problem
Comments:			
REPLACEMENT/REHABILITATION			
Next Rehab. Date:	2018	Replacement Year:	2018
Antic. Rehab. Cost:	\$0.00	Replacement Cost:	\$0.00
Recommendations:			
OBSERVATIONS			
Overall Condition:	F2 - Fair (Inspection within 2 Years)	Requires Further Inspection:	No
Additional Observations:			
LEGEND:			
Condition Definitions:			
1 - *Good - [discontinued code].	F2 - Fair (Inspection within 2 Years).	C - Unsafe (Closed to Public).	Problem Definitions:
2 - *Fair - [discontinued code].	F1 - Fair (Inspection within 1 Year).	U - Uninspectable.	N - No Problem.
3 - *Poor - [discontinued code].	P3 - Poor (Repair within 3 Years).	I - Inapplicable.	P - Possible Problem.
