GOVERNMENT OF NEWFOUNDLAND AND LABRADOR Department of Transportation and Infrastructure	BRIDGE INSPECTION REPORT B09172021-4	
Date: 3/7/2019	Inspected By: Pickett R	Category: Eng. - Engineering	
BRIDGE INFORMATION			
Site:	1-241 - HODGEWATER OVERPASS (CBN BY-PASS)		
Route:	75	Overall Length:	39.8 m
Year Built:	1995	Est: No	Overall Width: 14.5 m
Year Last Rehab.:		Est: No	Roadway Width: 12.5 m
Region:	AVALON PENINSULA	Sidewalk Width:	1 m
Jurisdiction:	Provincial	Clearance to R.D. or N.W.L.:	5.1 m
Type of Structure:	04 - Rigid Frame	Max Depth of N.W.L.:	0 m
Purpose of Structure:	01 - Highway Grade Separation	Spans:	
Type of Handrail:	01 - Aluminum Rail	<u>Span No.:</u>	<u>Length</u>
Roadway Surface:	02 - Asphalt	<u>Span No.:</u>	<u>Length</u>
Alignment Vertical:	01 - Good	1	15.5
Alignment Horizontal:	01 - Good	2	0
Restrictions:	No	3	0
		4	0
		5	0
		6	0
BRIDGE PHOTOS

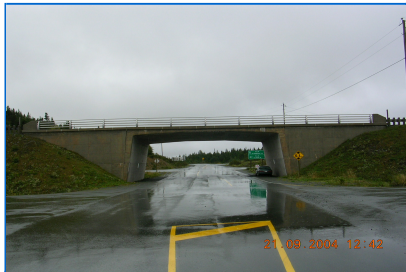
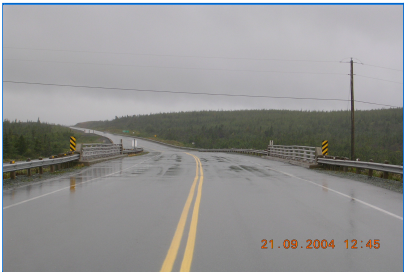
Bearing Seat:	I - Inapplicable
Comments:	- Assumed cond. of buried reinf. conc. frame leg and wingwall footings		
SUPERSTRUCTURE			
Condition:	F1 - Fair	Expansion Joints:	I - Inapplicable
Comments:	- All frame megs at corners have wide vert./angular cracks with heavy efflor. deposits, some extend into soffit - Exterior soffit has wide longit. cracks and delamin. - Extensive med. alligator cracks with med. efflor. deposits on all wingwalls - NE wingwall tipped out approx 40 mm beyond frame leg - Outside curb and fascias has wide cracks delamin. and disintegration into rail anchors on south side. Remainder of outside curb fascias and soffit has wide cracks with heavy efflor. deposits		
DECK

Condition:	F2 - Fair	Curbs:	P1 - Poor
Hand Rail:	F2 - Fair	Roadway Condition:	P1 - Poor
Approach Rail:	F2 - Fair		
Comments:	- Vertical cracks med./narrow in top of curbs, extensive medium alligator cracks in all 4 wingwalls with med. efflor. deposits and wide cracks

Next Rehab. Date:	2021	Replacement Year:	2045
Antic. Rehab. Cost:	\$100	Replacement Cost:	\$800
Recommendations:	- Curb and soffit should be repaired as delam. with wide cracks are over traffic areas
