GOVERNMENT OF NEWFOUNDLAND AND LABRADOR Department of Transportation and Infrastructure	BRIDGE INSPECTION REPORT B10282015-10	
Date: 9/23/2015	Inspected By: Rodger Hussey	Category: Eng. - Engineering	
BRIDGE INFORMATION			
Site:	TCH-139 - HOLYROOD ACCESS ROAD OVERPASS-EASTBOUND		
Route:	1	Overall Length:	0 m
Year Built:	1991	Est: No	Overall Width: 12.35 m
Year Last Rehab.:		Est: No	Roadway Width: 10.35 m
Region:	AVALON PENINSULA	Sidewalk Width:	1 m
Jurisdiction:	Provincial	Clearance to R.D. or N.W.L.:	5.2 m
Type of Structure:	04 - Rigid Frame	Max Depth of N.W.L.:	0 m
Purpose of Structure:	01 - Highway Grade Separation	Spans:	
Type of Handrail:	01 - Aluminum Rail	Span No.:	Length
Roadway Surface:	02 - Asphalt	1	20.4
Alignment Vertical:	01 - Good	2	0
Alignment Horizontal:	01 - Good	3	0
Restrictions:	No	6	0
BRIDGE PHOTOS

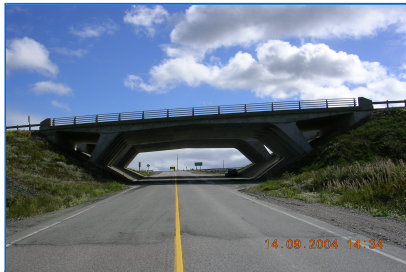
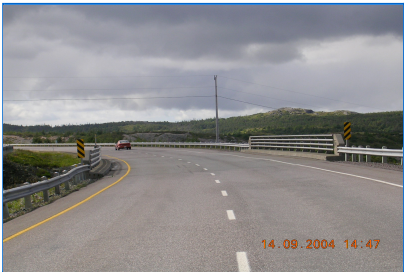
Comments:	Minor cracking throughout abutments and struts; Minor/moderate map cracking throughout headwalls.		
SUPERSTRUCTURE			
Condition:	F2 - Fair	Expansion Joints:	I - Inapplicable
Comments:	Minor cracking throughout underside of deck.		
DECK			
Condition:	P3 - Poor	Curbs:	F2 - Fair
Hand Rail:	G - Good	Roadway Condition:	F2 - Fair

Approach Rail:	F2 - Fair		
Comments:	Numerous potholes in driving surface; Minor damage from snow equipment to approach rails; Minor cracking and spalling throughout fascia.		
HYDROLOGY			
Water Velocity:	0 m/s	Ice Problem:	NA - Not Applicable
Water Depth:	0 m	Scour Problem:	NA - Not Applicable
Waterway:	03 - Not Applicable	Debris Problem:	NA - Not Applicable
Comments:			
REPLACEMENT/REHABILITATION			
Next Rehab. Date:	2015	Replacement Year:	2015
Antic. Rehab. Cost:	\$0	Replacement Cost:	\$0
Recommendations:	Patch or repave driving surface. Install hazard marker (1).		
OBSERVATIONS			
Overall Condition:	F2 - Fair	Requires Further Inspection:	No
Additional Observations:	Hazard marker missing (1).		
LEGEND:			
Condition Definitions:		Problem Definitions:	
1 - *Good - [discontinued code].	F2 - Fair.	C - Unsafe (Closed to Public).	N - No Problem.
2 - *Fair - [discontinued code].	F1 - Fair.	U - Uninspectable.	P - Possible Problem.
