GOVERNMENT OF NEWFOUNDLAND AND LABRADOR Department of Transportation and Infrastructure	BRIDGE INSPECTION REPORT B09102021-2	
Date: 4/17/2020	Inspected By: Hunt R	Category: Eng. - Engineering	
BRIDGE INFORMATION			
Site:	1-132 - HOPEALL BRIDGE		
Route:	80	Overall Length:	25.2 m
Year Built:	1991	Est: No	Overall Width: 8.6 m
Year Last Rehab.:		Est: No	Roadway Width: 6.6 m
Region:	AVALON PENINSULA	Sidewalk Width:	1.55 m
Jurisdiction:	Provincial	Clearance to R.D. or N.W.L.:	1.4 m
Type of Structure:	04 - Rigid Frame	Max Depth of N.W.L.:	0.7 m
Purpose of Structure:	04 - Over Non-Navigable Waters		
Type of Handrail:	01 - Aluminum Rail	Spans:	
Roadway Surface:	02 - Asphalt	<u>Span No.:</u>	<u>Length</u>
Alignment Vertical:	01 - Good	1	8.9
Alignment Horizontal:	01 - Good	2	8.9
Restrictions:	No	3	0
		4	0
		5	0
		6	0
BRIDGE PHOTOS

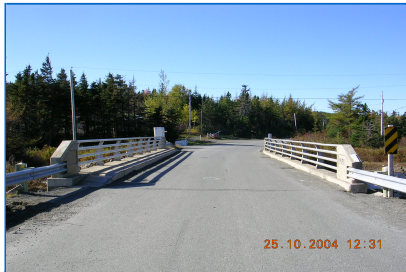
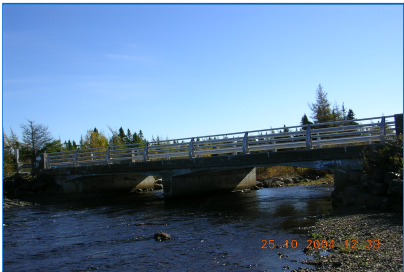
Comments:	- Assumed condition of buried/submerged reinf. conc. frame legs/pier footings and levelling/mud slabs.		
SUPERSTRUCTURE			
Condition:	F1 - Fair	Expansion Joints:	I - Inapplicable
Comments:	- Medium vertical cracks in faces of frame legs and pier. - Medium alligator cracking in tops of 4 wingwalls - Medium erosion along bottoms of frame legs and pier		
DECK			
Condition:	F2 - Fair	Curbs:	F1 - Fair
Hand Rail:	F2 - Fair	Roadway Condition:	F1 - Fair

Approach Rail:	F1 - Fair
Comments:	- Narrow trans./long. cracks in deck soffit. - No hazard markers at NW, SW, and SE ends. - Medium horiz./vert. cracks with light efflor. deposits in deck/curb fascia. - Wide trans. cracks in asphalt along app. slab edges. - Numerous medium potholes in asphalt on deck and approaches - Medium/wide trans./vert. cracks in curb surfaces and interior fascia. - Wide trans. crack in SE curb (wheelchair ramp). - Numerous wide alligator cracks in 4 end blocks. Top still sheared off NW end block. - Medium scrapes, dents, with end caps missing in aluminum rails - Medium damage to approach/exit rail with scrapes/dents and decaying posts

Next Rehab. Date:	2021	Replacement Year:	2041
Antic. Rehab. Cost:	\$70	Replacement Cost:	\$1000
Recommendations:	- Repair all concrete defects. - Resurface deck and approaches. - Repair guiderail and alum. rails. - In the interim, install 4 new hazard markers (maint).
