GOVERNMENT OF NEWFOUNDLAND AND LABRADOR Department of Transportation and Infrastructure	<b>BRIDGE INSPECTION REPORT</b> <b>B06192019-8</b>	
<b>Date:</b> 6/19/2019	<b>Inspected By:</b> Hunt R	<b>Category:</b> Eng. - Engineering	
<b>BRIDGE INFORMATION</b>			
<b>Site:</b>	1-147 - MAKINSONS BRIDGE, GOULDS RIVER		
<b>Route:</b>	71	<b>Overall Length:</b>	28.1 m
<b>Year Built:</b>	1985	<b>Est:</b> No	<b>Overall Width:</b> 10 m
<b>Year Last Rehab.:</b>		<b>Est:</b> No	<b>Roadway Width:</b> 8.1 m
<b>Region:</b>	AVALON PENINSULA	<b>Sidewalk Width:</b>	1 m
<b>Jurisdiction:</b>	Provincial	<b>Clearance to R.D. or N.W.L.:</b>	2.2 m
<b>Type of Structure:</b>	04 - Rigid Frame	<b>Max Depth of N.W.L.:</b>	1 m
<b>Purpose of Structure:</b>	04 - Over Non-Navigable Waters	<b>Spans:</b>	
<b>Type of Handrail:</b>	01 - Aluminum Rail	<u>Span No.:</u>	<u>Length</u>
<b>Roadway Surface:</b>	02 - Asphalt	1	20.1
<b>Alignment Vertical:</b>	01 - Good	2	0

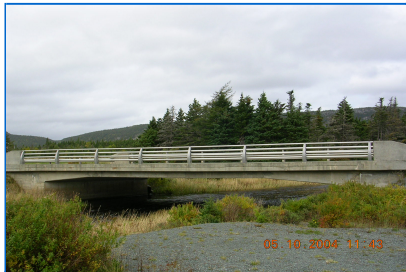
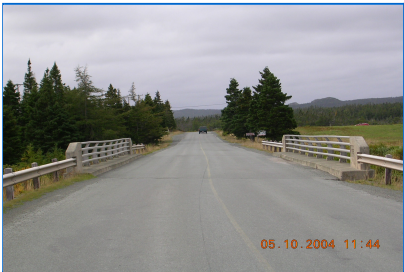
<b>SUBSTRUCTURE</b>			
<b>Condition:</b>	F2 - Fair	<b>Bearings:</b>	I - Inapplicable
		<b>Bearing Seat:</b>	I - Inapplicable
<b>Comments:</b>	Assumed condition of submerged frame leg footings.		
<b>SUPERSTRUCTURE</b>			
<b>Condition:</b>	F2 - Fair	<b>Expansion Joints:</b>	I - Inapplicable
<b>Comments:</b>	Narrow vertical cracks in frame legs with light efflor deposits. Medium vertical horizontal cracks with light efflor deposits. Medium vertical angular cracks with efflor deposits to faces of frame legs.		
<b>DECK</b>			
<b>Condition:</b>	F2 - Fair	<b>Curbs:</b>	F2 - Fair
<b>Hand Rail:</b>	F2 - Fair	<b>Roadway Condition:</b>	F2 - Fair

<b>Approach Rail:</b>	F1 - Fair
<b>Comments:</b>	Medium longitudinal cracks with heavy efflor deposits to deck soffit and facias. No hazard markers at end blocks. Medium horizontal vertical transverse cracks in tops of facias at both curbs. Narrow transverse cracks with light efflor deposits in deck soffit. Medium alligator cracks in all four end blocks. Medium transverse longitudinal cracks with potholes in asphalt surface.

<b>Water Velocity:</b>	0.4 m/s	<b>Ice Problem:</b>	N - No Problem
<b>Water Depth:</b>	0.5 m	<b>Scour Problem:</b>	N - No Problem
<b>Waterway:</b>	01 - Adequate	<b>Debris Problem:</b>	N - No Problem
<b>Comments:</b>	Moderate slope erosion on corners of structure.

<b>Next Rehab. Date:</b>	2022	<b>Replacement Year:</b>	2035
<b>Antic. Rehab. Cost:</b>	\$150	<b>Replacement Cost:</b>	\$1000
<b>Recommendations:</b>	Install new guiderail and hazard markers. Resurface deck and approaches. Repair concrete defects and fix erosion on corners of surface
