GOVERNMENT OF NEWFOUNDLAND AND LABRADOR Department of Transportation and Infrastructure	<b>BRIDGE INSPECTION REPORT</b> <b>B09142021-8</b>	
<b>Date:</b> 2/25/2020	<b>Inspected By:</b> Chris Lyver	<b>Category:</b> Eng. - Engineering	
<b>BRIDGE INFORMATION</b>			
<b>Site:</b>	1-161 - MALL BAY BRIDGE		
<b>Route:</b>		<b>Overall Length:</b>	25.9 m
<b>Year Built:</b>	1985	<b>Est: Yes</b>	<b>Overall Width:</b> 0 m
<b>Year Last Rehab.:</b>		<b>Est: No</b>	<b>Roadway Width:</b> 0 m
<b>Region:</b>	AVALON PENINSULA	<b>Sidewalk Width:</b>	0 m
<b>Jurisdiction:</b>	Provincial	<b>Clearance to R.D. or N.W.L.:</b>	0 m
<b>Type of Structure:</b>	04 - Rigid Frame	<b>Max Depth of N.W.L.:</b>	0 m
<b>Purpose of Structure:</b>	04 - Over Non-Navigable Waters		
<b>Type of Handrail:</b>	06 - None	<b>Spans:</b>	
<b>Roadway Surface:</b>	01 - Concrete	<u>Span No.:</u>	<u>Length</u>
<b>Alignment Vertical:</b>	01 - Good	1	12.7
<b>Alignment Horizontal:</b>	02 - Adequate	2	0

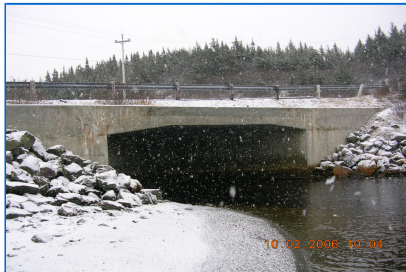
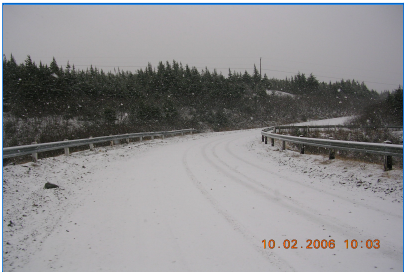
<b>SUBSTRUCTURE</b>			
<b>Condition:</b>	F2 - Fair	<b>Bearings:</b>	I - Inapplicable
		<b>Bearing Seat:</b>	I - Inapplicable
<b>Comments:</b>	- Assumed condition of buried/ submerged reinforced concrete frame leg footings. - Medium erosion along bottom faces of frame leg footings (visible through water).		
<b>SUPERSTRUCTURE</b>			
<b>Condition:</b>	F1 - Fair	<b>Expansion Joints:</b>	I - Inapplicable
<b>Comments:</b>	- Numerous medium vertical/angular cracks with heavy efflor./stalactite deposits in faces of frame. Cracks extend across haunch into deck - Severe small/medium spall with medium corrosion to exposed reinf. at base of east frame leg (middle at const. joint) - Narrow map cracking with med efflor. deposits in 4 wingwalls - Light /med delamin./spalling at corners of frame legs		
<b>DECK</b>

<b>Condition:</b>	F1 - Fair	<b>Curbs:</b>	I - Inapplicable
<b>Hand Rail:</b>	I - Inapplicable	<b>Roadway Condition:</b>	I - Inapplicable
<b>Approach Rail:</b>	P3 - Poor		
<b>Comments:</b>	- Numerous medium long./angular cracks with heavy efflor./stalactite deposits in deck soffit - Med./wide horiz. cracks opening up along const. joints in deck fascia's - Guiderail continues to age with dents, scrapes; decaying posts

<b>Water Velocity:</b>	tidal m/s	<b>Ice Problem:</b>	N - No Problem
<b>Water Depth:</b>	tidal m	<b>Scour Problem:</b>	N - No Problem
<b>Waterway:</b>	01 - Adequate	<b>Debris Problem:</b>	N - No Problem
<b>Comments:</b>	- Severe slope erosion continues at NW corner of structure, erosion extends under NW wingwall (rip-rap has migrated into channel) Minor rip-rap migration at remaining 3 corners

<b>Next Rehab. Date:</b>	2020	<b>Replacement Year:</b>	2049
<b>Antic. Rehab. Cost:</b>	\$80	<b>Replacement Cost:</b>	\$750
<b>Recommendations:</b>	- Repair all conc. defects - Repair slope erosion at NW end - Replace aging guiderail - Install new rip-rap as required at corners
