GOVERNMENT OF NEWFOUNDLAND AND LABRADOR Department of Transportation and Infrastructure	BRIDGE INSPECTION REPORT B10282015-11	
Date: 9/23/2015	Inspected By: Rodger Hussey	Category: Eng. - Engineering	
BRIDGE INFORMATION			
Site:	TCH-106 - MANUEL'S RIVER SPILLWAY BRIDGE		
Route:	1	Overall Length:	21.4 m
Year Built:	1958	Est: No	Overall Width: 14.6 m
Year Last Rehab.:		Est: No	Roadway Width: 11.6 m
Region:	AVALON PENINSULA	Sidewalk Width:	1.5 m
Jurisdiction:	Provincial	Clearance to R.D. or N.W.L.:	7.2 m
Type of Structure:	03 - Reinforced Concrete Beam/Slab	Max Depth of N.W.L.:	0.1 m
Purpose of Structure:	04 - Over Non-Navigable Waters	Spans:	
Type of Handrail:	02 - Concrete Rail	<u>Span No.:</u>	<u>Length</u>
Roadway Surface:	02 - Asphalt	1	6.6
Alignment Vertical:	01 - Good	2	0
Alignment Horizontal:	01 - Good	3	0
Restrictions:	No	6	0
BRIDGE PHOTOS

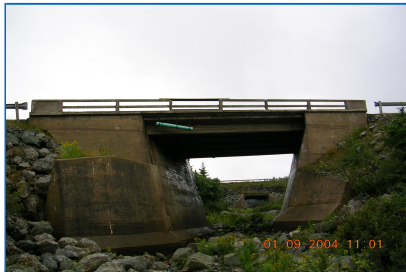
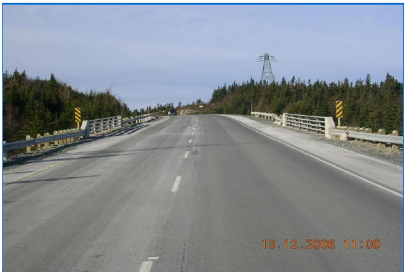
Bearing Seat:	F2 - Fair
Comments:	Abutments have moderate spalling at abutment/headwall interface; Minor/moderate cracking throughout abutments, wingwalls, and headwalls, efflorescence deposits in cracking; Moderate erosion to eastern footing.		
SUPERSTRUCTURE			
Condition:	F2 - Fair	Expansion Joints:	I - Inapplicable
Comments:	Minor/moderate cracking throughout girders, soffit, fascia and underside of bridge deck, efflorescence in cracking.		
DECK			
Condition:	F2 - Fair	Curbs:	F2 - Fair
Hand Rail:	F2 - Fair	Roadway Condition:	F2 - Fair

Approach Rail:	P1 - Poor		
Comments:	Northeast section of approach rail damaged; Minor rutting/raveling of driving surface.		
HYDROLOGY			
Water Velocity:	0 m/s	Ice Problem:	N - No Problem
Water Depth:	0 m	Scour Problem:	P - Possible Problem
Waterway:	01 - Adequate	Debris Problem:	N - No Problem
Comments:			
REPLACEMENT/REHABILITATION			
Next Rehab. Date:	2015	Replacement Year:	2015
Antic. Rehab. Cost:	\$0	Replacement Cost:	\$0
Recommendations:	Replace damaged approach rail; Install hazard marker (1).		
OBSERVATIONS			
Overall Condition:	F2 - Fair	Requires Further Inspection:	No
Additional Observations:	Missing hazard marker (1).		
LEGEND:			
Condition Definitions:			
1 - *Good - [discontinued code].	F2 - Fair.	C - Unsafe (Closed to Public).	Problem Definitions:
2 - *Fair - [discontinued code].	F1 - Fair.	U - Uninspectable.	N - No Problem.
3 - *Poor - [discontinued code].	P3 - Poor.	I - Inapplicable.	P - Possible Problem.
