GOVERNMENT OF NEWFOUNDLAND AND LABRADOR Department of Transportation and Infrastructure	BRIDGE INSPECTION REPORT B10272015-9	
Date: 10/25/2015	Inspected By: Rodger Hussey	Category: Eng. - Engineering	
BRIDGE INFORMATION			
Site:	1-323 - MANUELS RAMP OVERPASS		
Route:	2	Overall Length:	0 m
Year Built:	1996	Overall Width:	8.7 m
Year Last Rehab.:		Roadway Width:	7.8 m
Region:	AVALON PENINSULA	Sidewalk Width:	0 m
Jurisdiction:	Provincial	Clearance to R.D. or N.W.L.:	5.1 m
Type of Structure:	05 - Pre-stressed Concrete Slab	Max Depth of N.W.L.:	0 m
Purpose of Structure:	01 - Highway Grade Separation	Spans:	
Type of Handrail:	05 - Concrete Barrier	<u>Span No.:</u>	<u>Length</u>
Roadway Surface:	02 - Asphalt	1	30.1
Alignment Vertical:	01 - Good	2	0
Alignment Horizontal:	01 - Good	3	0
Restrictions:	Yes	Span No.:	Length
Describe Restrictions:	One lane, One way traffic- (South Bound). Structure is located on horizontal curve to LT.

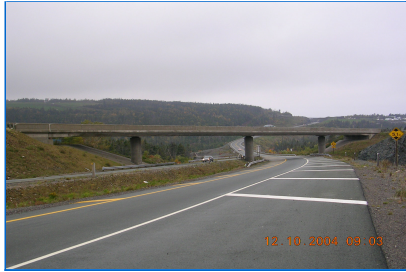
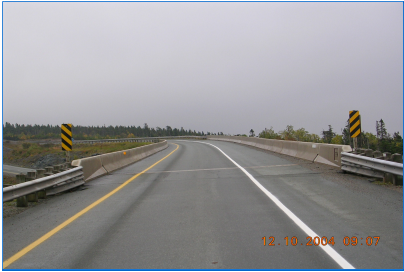
BRIDGE PHOTOS

Approach Rail:	P3 - Poor		
Comments:	Minor rutting of roadway; Small areas of asphalt stripping; Minor approach rail damage, end post detached, snow equipment damage; Jersey barrier handrail, no curbs.		
HYDROLOGY			
Water Velocity:	0 m/s	Ice Problem:	NA - Not Applicable
Water Depth:	0 m	Scour Problem:	NA - Not Applicable
Waterway:	03 - Not Applicable	Debris Problem:	NA - Not Applicable
Comments:			
REPLACEMENT/REHABILITATION			
Next Rehab. Date:	2015	Replacement Year:	2015
Antic. Rehab. Cost:	\$0	Replacement Cost:	\$0
Recommendations:	Repair approach rail; Monitor driving surface condition.		
OBSERVATIONS			
Overall Condition:	G - Good	Requires Further Inspection:	No
Additional Observations:			
LEGEND:			
Condition Definitions:		Problem Definitions:	
1 - *Good - [discontinued code].	F2 - Fair.	C - Unsafe (Closed to Public).	N - No Problem.
2 - *Fair - [discontinued code].	F1 - Fair.	U - Uninspectable.	P - Possible Problem.
