GOVERNMENT OF NEWFOUNDLAND AND LABRADOR Department of Transportation and Infrastructure	BRIDGE INSPECTION REPORT B05282019-5	
Date: 5/28/2019	Inspected By: Hunt R	Category: Eng. - Engineering	
BRIDGE INFORMATION			
Site:	1-149 - NORTH ARM BRIDGE, HOLYROOD		
Route:		Overall Length:	26 m
Year Built:	1984	Est: No	Overall Width: 10 m
Year Last Rehab.:		Est: No	Roadway Width: 9.2 m
Region:	AVALON PENINSULA	Sidewalk Width:	0 m
Jurisdiction:	Provincial	Clearance to R.D. or N.W.L.:	4.4 m
Type of Structure:	03 - Reinforced Concrete Beam/Slab	Max Depth of N.W.L.:	0.5 m
Purpose of Structure:	04 - Over Non-Navigable Waters	Spans:	
Type of Handrail:	01 - Aluminum Rail	<u>Span No.:</u>	<u>Length</u>
Roadway Surface:	02 - Asphalt	1	11.4
Alignment Vertical:	01 - Good	2	0
Alignment Horizontal:	02 - Adequate	3	0
Restrictions:	No	6	0
BRIDGE PHOTOS

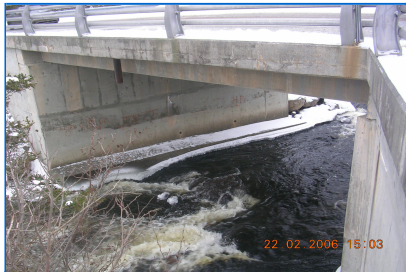
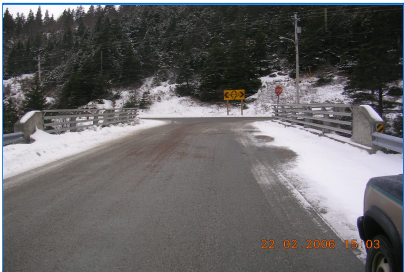
Comments:	Light erosion to tops and faces of partially submerged abutment footings. Bearing and bearing seat inspections restricted due to height. Narrow-medium vertical/alliation cracks with light efflon deposits on wingwall. Light delamination/spacing with light efflon deposits to extension abutment faces under expansion gabs on curbs.		
SUPERSTRUCTURE			
Condition:	F2 - Fair	Expansion Joints:	F2 - Fair
Comments:	Medium cracks with light efflon in extension creep blocks. Beam remain fairly in good condition. Alligator cracks in all four end blocks and expansion joints. Pads at semi-interval abutments.		
DECK			
Condition:	F2 - Fair	Curbs:	F1 - Fair

Hand Rail:	F2 - Fair	Roadway Condition:	F1 - Fair
Approach Rail:	G - Good		
Comments:	Narrow transverse cracks with light efflon deposits in extension cantilever deck soffit. Medium vertical transverse horizontal crack in deck curb and facials. Light corrosion to deck downspouts. All damaged approach and exit rail repaired or new rail installed in 2017 rehab. Damaged section of aluminum hand rail replaced or used rail installed. Some settlement present on road surface at expansion gap location.

Next Rehab. Date:	2019	Replacement Year:	2034
Antic. Rehab. Cost:	\$0	Replacement Cost:	\$1100
Recommendations:	Hazard markers not with new guard rail - should be installed. New approach and exit rail and new aluminum handrail installed in 2017 rehab.
