GOVERNMENT OF NEWFOUNDLAND AND LABRADOR Department of Transportation and Infrastructure	BRIDGE INSPECTION REPORT B09132021-9	
Date: 2/18/2020	Inspected By: Gillis M	Category: Eng. - Engineering	
BRIDGE INFORMATION			
Site:	1-276 - NORTH HARBOUR RIVER BRIDGE, RT.91		
Route:	91	Overall Length:	19.65 m
Year Built:	2001	Est: No	Overall Width: 10.1 m
Year Last Rehab.:		Est: No	Roadway Width: 8.8 m
Region:	AVALON PENINSULA	Sidewalk Width:	0.65 m
Jurisdiction:	Provincial	Clearance to R.D. or N.W.L.:	2.6 m
Type of Structure:	03 - Reinforced Concrete Beam/Slab	Max Depth of N.W.L.:	0.5 m
Purpose of Structure:	04 - Over Non-Navigable Waters	Spans:	
Type of Handrail:	01 - Aluminum Rail	<u>Span No.:</u>	<u>Length</u>
Roadway Surface:	01 - Concrete	1	10.9
Alignment Vertical:	01 - Good	2	0
Alignment Horizontal:	01 - Good	3	0
Restrictions:	No	Span No.:	Length
		4	0
		5	0
		6	0
BRIDGE PHOTOS

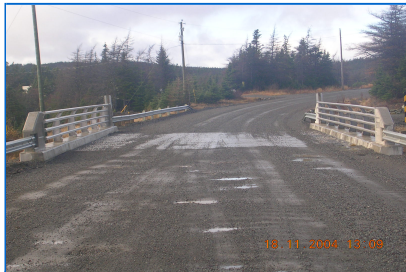
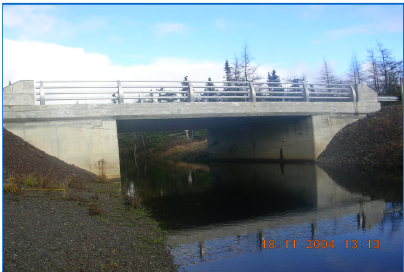
Bearing Seat:	F2 - Fair
Comments:	- Light erosion to east abutment footing, - Light erosion to bottom interior faces of abutments. - Light honeycombing in face of east abutment and NE wingwall. - Narrow hairline cracking in wingwalls. - Light bulging to bearing pads.		
SUPERSTRUCTURE			
Condition:	F2 - Fair	Expansion Joints:	F2 - Fair
Comments:	- No gap chalking in NW, SE and SW gaps in curb fascias and ext. abut. faces - NW end block has been struck causing delamin. and last spall at back/bottom of end block and curb fascia, light corrosion to exposed reinf. in this area - NW end block has been struck causing damage.		
DECK

Condition:	F2 - Fair	Curbs:	F2 - Fair
Hand Rail:	F2 - Fair	Roadway Condition:	F2 - Fair
Approach Rail:	F2 - Fair		
Comments:	- Narrow trans./vert. cracks in curb fascia and deck fascia. - Light scrapes, dents in guiderail. - Light scrapes, dents, missing splices on alum. handrail. - Light potholes in gravel approaches.

Water Velocity:	0.1 m/s	Ice Problem:	K - Known Problem
Water Depth:	0.3 m	Scour Problem:	N - No Problem
Waterway:	01 - Adequate	Debris Problem:	N - No Problem
Comments:	- Moderate shoulder/slope erosion at NE/NW ends of structure. - Light erosion on south ends.

Next Rehab. Date:	2038	Replacement Year:	2076
Antic. Rehab. Cost:	\$150	Replacement Cost:	\$500
Recommendations:	- Repair damaged NW end block and curb - Caulk exp. gaps in curb?abut. (NW,SW,SE) (maint.) - Repair slope erosion problems at 4 corners (maint.) - Install hyd. rip-rap at 4 corners of struct. (maint.)
