GOVERNMENT OF NEWFOUNDLAND AND LABRADOR Department of Transportation and Infrastructure	<b>BRIDGE INSPECTION REPORT</b> <b>B06042019-2</b>	
<b>Date:</b> 6/4/2019	<b>Inspected By:</b> Hunt R	<b>Category:</b> Eng. - Engineering	
<b>BRIDGE INFORMATION</b>			
<b>Site:</b>	1-299 - NORTHWEST POND BROOK BRIDGE		
<b>Route:</b>	20	<b>Overall Length:</b>	11.5 m
<b>Year Built:</b>	1970	<b>Est: No</b>	<b>Overall Width:</b> 8.5 m
<b>Year Last Rehab.:</b>		<b>Est: No</b>	<b>Roadway Width:</b> 7.9 m
<b>Region:</b>	AVALON PENINSULA	<b>Sidewalk Width:</b>	0 m
<b>Jurisdiction:</b>	Provincial	<b>Clearance to R.D. or N.W.L.:</b>	1.5 m
<b>Type of Structure:</b>	03 - Reinforced Concrete Beam/Slab	<b>Max Depth of N.W.L.:</b>	0.1 m
<b>Purpose of Structure:</b>	04 - Over Non-Navigable Waters	<b>Spans:</b>	
<b>Type of Handrail:</b>	02 - Concrete Rail	<u>Span No.:</u>	<u>Length</u>
<b>Roadway Surface:</b>	02 - Asphalt	1	5.5
<b>Alignment Vertical:</b>	01 - Good	2	0

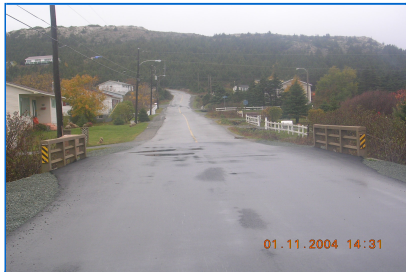
<b>SUBSTRUCTURE</b>			
<b>Condition:</b>	F2 - Fair	<b>Bearings:</b>	F2 - Fair
		<b>Bearing Seat:</b>	F2 - Fair
<b>Comments:</b>	P1 - abutment corners and wingwalls. F2 - remainder. Medium erosion to partially berried submerged concrete abutment footings. Narrow/medium vertical angular cracks with light efflor deposits at abutment corners. Medium vertical horizontal cracks at abutment faces. Severe delamination/spalling/disintegration to both corners of South abutments. Very wide vertical movement cracks in both north wingwall at intersections with abutment and deck. Severe delamination/ spalling/ disintegration to top faces of 4 wingwalls.		
<b>SUPERSTRUCTURE</b>			
<b>Condition:</b>	F2 - Fair	<b>Expansion Joints:</b>	F2 - Fair
<b>Comments:</b>	No visible signs of expansion joints(Paved over on deck). No end blocks.

<b>Next Rehab. Date:</b>	2019	<b>Replacement Year:</b>	2030
<b>Antic. Rehab. Cost:</b>	\$100	<b>Replacement Cost:</b>	\$350
<b>Recommendations:</b>	Repair abutment corners, wingwalls and facials on deck. Install approach/exit guiderail complete with hazard markers where possible.

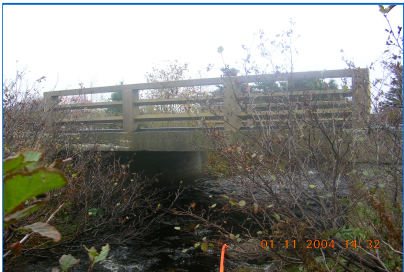
<b>Condition:</b>	F2 - Fair	<b>Curbs:</b>	I - Inapplicable
<b>Hand Rail:</b>	F2 - Fair	<b>Roadway Condition:</b>	I - Inapplicable
<b>Approach Rail:</b>	I - Inapplicable		
<b>Comments:</b>	P1 - deck facials. F2 - remainder. Severe delamination/spalling/disintegration continues to downstream deck facials. Narrow horizontal/vertical cracks with medium spalling to upstream deck facials. Medium honey combing to some areas of deck soffit. Longitudinal joint in asphalt opening up on approaches. Some small potholes and asphalt reviling on surface over deck. Concrete handrail remains in fairly good condition.
