GOVERNMENT OF NEWFOUNDLAND AND LABRADOR Department of Transportation and Infrastructure	BRIDGE INSPECTION REPORT B11172021-3	
Date: 10/19/2021	Inspected By: Mike Button	Category: Office - Bridge Office	
BRIDGE INFORMATION			
Site:	1-245 - OLD SHOP POND BRIDGE		
Route:		Overall Length:	11.5 m
Year Built:	1985	Est: Yes	Overall Width: 10.6 m
Year Last Rehab.:		Est: No	Roadway Width: 6 m
Region:	AVALON PENINSULA	Sidewalk Width:	0 m
Jurisdiction:	Provincial	Clearance to R.D. or N.W.L.:	0.8 m
Type of Structure:	04 - Rigid Frame	Max Depth of N.W.L.:	0.9 m
Purpose of Structure:	04 - Over Non-Navigable Waters	Spans:	
Type of Handrail:	02 - Concrete Rail	Span No.:	Length
Roadway Surface:	02 - Asphalt	1	6.6
Alignment Vertical:	01 - Good	2	0
Alignment Horizontal:	02 - Adequate	3	0
Restrictions:	No	Span No.:	Length
		4	0
		5	0
		6	0
BRIDGE PHOTOS

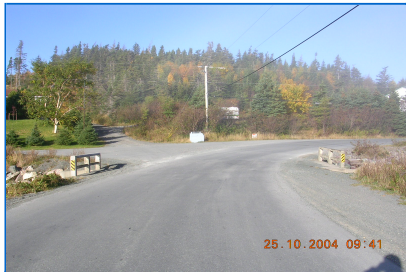
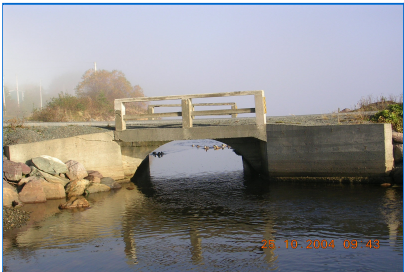
Bearing Seat:	P3 - Poor
Comments:	- Southwest wingwall transition to the fascia has a large section of concrete cracked off the main wingwall with exposed reinforcement but still in place, F1. - Southeast wingwall has mild-medium map cracking throughout with efflorescence. About two-thirds of the way up the wingwall, there is a wide horizontal crack extending across the wall. Both downstream wingwall to fascia connections have medium wide cracks with efflorescence. The northwest wingwall has wide horizontal cracks throughout. - The upstream arch support has mild to medium concrete deterioration. The joint 300mm below the deck soffit is opening up with mild efflorescence leakage. - The west and east frame leg to deck transition joint is leaking with visible water coming down the frame leg face in various locations. There is also some locations with mild cracking with efflorescence. - Frame legs have mild erosion around the waterline but otherwise in fair condition, F1 - Looking under the structure from both the upstream and downstream sides, both frame leg extensions have different slopes or settlement near the extension joints. - Both frame leg extension construction joints opening up under the structure. *Inspection limited as there is no access under structure due to water depth*

SUPERSTRUCTURE			
Condition:	F1 - Fair	Expansion Joints:	I - Inapplicable
Comments:	- South soffit has mild cracking with efflorescence. Bottom of deck, looking from outside the structure on both the upstream and downstream sides, looks to be in fair condition. No visible efflorescence on the bottom of the deck. *Inspection limited as there is no access under structure due to water depth*		
DECK			
Condition:	F1 - Fair	Curbs:	I - Inapplicable
Hand Rail:	F1 - Fair	Roadway Condition:	P3 - Poor
Approach Rail:	I - Inapplicable		
Comments:	- Asphalt has a medium/large pot hole on the northeast corner, area also appears to be settled, P3. Otherwise asphalt is in fair condition. - No end blocks, hazard markers, energy dampening posts or approach/exit rail. - Structure handrail is normal guiderail and is in fair condition, F1. Original concrete handrail is destroyed. - Earth fill atop rigid frame, moderate vegetation growth on the shoulders. *Inspection limited as there is no access under structure due to water depth*

HYDROLOGY			
Water Velocity:	Tidal m/s	Ice Problem:	N - No Problem
Water Depth:	Tidal m	Scour Problem:	P - Possible Problem
Waterway:	01 - Adequate	Debris Problem:	N - No Problem
Comments:	- Rip rap on the southeast wingwall has migrated into the channel and needs replacement. Possible scour as bridge is in a tidal zone.		
REPLACEMENT/REHABILITATION			
Next Rehab. Date:	2028	Replacement Year:	2035
Antic. Rehab. Cost:	\$50,000	Replacement Cost:	\$1,000,000
Recommendations:	- Repair concrete defects on the wingwalls and fascias. Install approach rails and hazard markers.		
OBSERVATIONS			
Overall Condition:	P3 - Poor	Requires Further Inspection:	No
Additional Observations:	- Inspection limited as there is no access under structure due to water depth. Need chest waders for proper inspection of this bridge. Hazards, mild traffic and working around water. P3 leakage/efflorescence at the frame leg to bottom of deck transition and sections of the fascia and wingwalls. F1 remainder.
