GOVERNMENT OF NEWFOUNDLAND AND LABRADOR Department of Transportation and Infrastructure	<b>BRIDGE INSPECTION REPORT</b> <b>B06182021-9</b>	
<b>Date:</b> 1/16/2020	<b>Inspected By:</b> Gillis M	<b>Category:</b> Eng. - Engineering	
<b>BRIDGE INFORMATION</b>			
<b>Site:</b>	1-359 - PETTY HARBOUR CULVERT NO.2		
<b>Route:</b>		<b>Overall Length:</b>	6.5 m
<b>Year Built:</b>	1990	<b>Est: No</b>	<b>Overall Width:</b> 10 m
<b>Year Last Rehab.:</b>		<b>Est: No</b>	<b>Roadway Width:</b> 9 m
<b>Region:</b>	AVALON PENINSULA	<b>Sidewalk Width:</b>	1.5 m
<b>Jurisdiction:</b>	Provincial	<b>Clearance to R.D. or N.W.L.:</b>	1.1 m
<b>Type of Structure:</b>	04 - Rigid Frame	<b>Max Depth of N.W.L.:</b>	0.2 m
<b>Purpose of Structure:</b>	04 - Over Non-Navigable Waters	<b>Spans:</b>	
<b>Type of Handrail:</b>	04 - Steel Rail	<u>Span No.:</u>	<u>Length</u>
<b>Roadway Surface:</b>	02 - Asphalt	<u>Span No.:</u>	<u>Length</u>

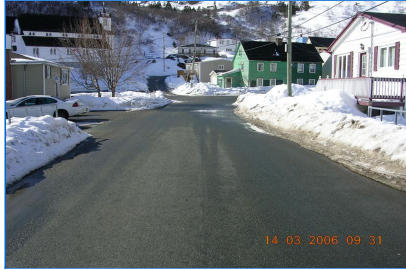
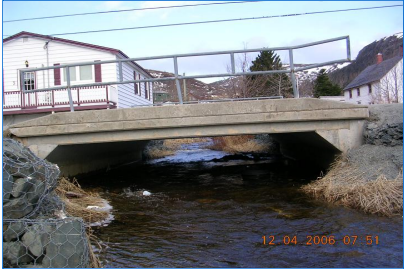
<b>SUBSTRUCTURE</b>			
<b>Condition:</b>	F2 - Fair	<b>Bearings:</b>	I - Inapplicable
		<b>Bearing Seat:</b>	I - Inapplicable
<b>Comments:</b>	- No visible footing. - Narrow vertical cracks in interior faces of frame legs.		
<b>SUPERSTRUCTURE</b>			
<b>Condition:</b>	F2 - Fair	<b>Expansion Joints:</b>	I - Inapplicable
<b>Comments:</b>			
<b>DECK</b>			
<b>Condition:</b>	F2 - Fair	<b>Curbs:</b>	F2 - Fair
<b>Hand Rail:</b>	F1 - Fair	<b>Roadway Condition:</b>	F2 - Fair

<b>Approach Rail:</b>	I - Inapplicable		
<b>Comments:</b>	Narrow long. and trans cracks to underside of deck soffit/ fascia and curbs, sidewalks. - Handrails tipped with minor rusting, NW corner has small section missing.		
<b>HYDROLOGY</b>			
<b>Water Velocity:</b>	0.2 m/s	<b>Ice Problem:</b>	P - Possible Problem
<b>Water Depth:</b>	0.3 m	<b>Scour Problem:</b>	N - No Problem
<b>Waterway:</b>	01 - Adequate	<b>Debris Problem:</b>	P - Possible Problem
<b>Comments:</b>	- Gabion basket bulging in all 4 corners.		
<b>REPLACEMENT/REHABILITATION</b>			
<b>Next Rehab. Date:</b>	2022	<b>Replacement Year:</b>	2040
<b>Antic. Rehab. Cost:</b>	\$20000	<b>Replacement Cost:</b>	\$150000
<b>Recommendations:</b>	- Repair handrail and install hazard markers.		
<b>OBSERVATIONS</b>			
<b>Overall Condition:</b>	F2 - Fair	<b>Requires Further Inspection:</b>	No
<b>Additional Observations:</b>	- Unchanged from 2018 inspection.
