GOVERNMENT OF NEWFOUNDLAND AND LABRADOR Department of Transportation and Infrastructure	BRIDGE INSPECTION REPORT B06102019-3	
Date: 1/17/2019	Inspected By: Pickett R	Category: Eng. - Engineering	
BRIDGE INFORMATION			
Site:	1-289 - PICCO'S BROOK BRIDGE, FLATROCK		
Route:	20-17	Overall Length:	16.1 m
Year Built:	1925	Est: Yes	Overall Width: 7.8 m
Year Last Rehab.:	1965	Est: Yes	Roadway Width: 7.1 m
Region:	AVALON PENINSULA		Sidewalk Width: 0 m
Jurisdiction:	Provincial	Clearance to R.D. or N.W.L.:	4.5 m
Type of Structure:	04 - Rigid Frame	Max Depth of N.W.L.:	0.7 m
Purpose of Structure:	04 - Over Non-Navigable Waters		Spans:
Type of Handrail:	02 - Concrete Rail	Span No.:	Length
Roadway Surface:	02 - Asphalt	1	4.5
Alignment Vertical:	01 - Good	2	0
Alignment Horizontal:	02 - Adequate	3	0
Restrictions:	No		
BRIDGE PHOTOS

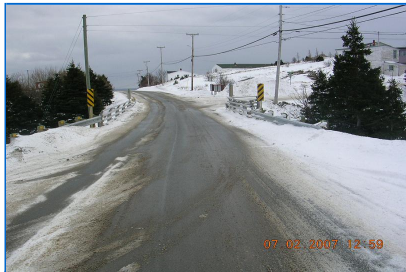
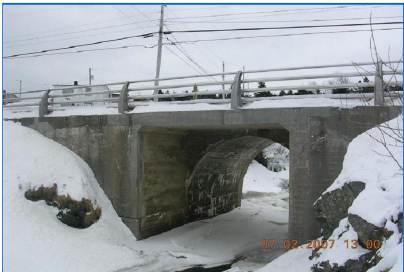
Comments:	Original concrete arch extended 5m downstream with rigid frame. No footing on original concrete arch at down stream rigid frame extension poured directly onto dowelled bed rock.		
SUPERSTRUCTURE			
Condition:	P1 - Poor	Expansion Joints:	I - Inapplicable
Comments:	Numerous wide horizontal vertical cracks with heavy efflor deposits in original arch abutments. Severe scouring at bases of original arch frame leg extensions. Some deuteriations at all four corners of arch abutments and extensions. Wingwalls have delamination and spalding, wide medium cracks with effloresce deposits.		
DECK			
Condition:	F1 - Fair	Curbs:	F1 - Fair

Hand Rail:	F2 - Fair	Roadway Condition:	F1 - Fair
Approach Rail:	F1 - Fair		
Comments:	Medium numerous long transverse cracks with heavy effloresce deposits in original deck soffit. Numerous wide cracks in downstream fascia original arch. Medium efflor deposits/ medium cracks in upstream curb fascias exposed rebar on downstream deck soffit original structure along with medium spading. Severe delamination/ Spalding on most wingwalls. Erosion at South west wingwall. Damage to aluminum railing due to snowplow impact. Damage to all approach and exit rail.

Water Velocity:	0.6 m/s	Ice Problem:	P - Possible Problem
Water Depth:	0.8 m	Scour Problem:	P - Possible Problem
Waterway:	01 - Adequate	Debris Problem:	N - No Problem
Comments:	Severe slope erosion at South East corner. Con erosion on remainder.

Next Rehab. Date:	2020	Replacement Year:	2030
Antic. Rehab. Cost:	\$300000	Replacement Cost:	\$900000
Recommendations:	Repair damage guide rail, handrails and install hazard markers. Fix slope erosion and concrete defects.
