GOVERNMENT OF NEWFOUNDLAND AND LABRADOR Department of Transportation and Infrastructure	BRIDGE INSPECTION REPORT B09232021-6	
Date: 1/28/2020	Inspected By: Hunt R	Category: Eng. - Engineering	
BRIDGE INFORMATION			
Site:	1-024 - PIERRE'S BROOK BRIDGE, WITLESS BAY		
Route:	10	Overall Length:	26.2 m
Year Built:	1966	Est: No	Overall Width: 10.7 m
Year Last Rehab.:		Est: No	Roadway Width: 9.1 m
Region:	AVALON PENINSULA	Sidewalk Width:	0.8 m
Jurisdiction:	Provincial	Clearance to R.D. or N.W.L.:	5.4 m
Type of Structure:	02 - Double Tee	Max Depth of N.W.L.:	0.2 m
Purpose of Structure:	04 - Over Non-Navigable Waters	Spans:	
Type of Handrail:	02 - Concrete Rail	Span No.:	Length
Roadway Surface:	02 - Asphalt	1	13.6
Alignment Vertical:	02 - Adequate	2	0
Alignment Horizontal:	02 - Adequate	3	0
Restrictions:	No	Span No.:	Length
		4	0
		5	0
		6	0
BRIDGE PHOTOS

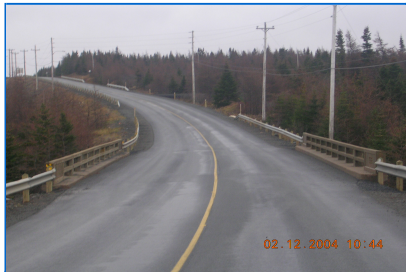
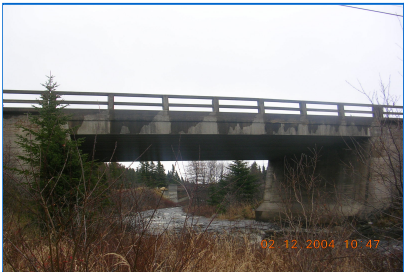
Bearing Seat:	P1 - Poor
Comments:	P1 - abutment corners F1 - remainder - Severe delamin. and disintegration on all four abutment corners. Medium/wide vert. cracks in wingwalls. - Very wide vert. cracks, severe delamin./ spalling with medium corrosion to exposed reinf. to exterior faces of NE, NW, and SE bearing seats and creep blocks. - No visible signs of bearings due to height restrictions.		
SUPERSTRUCTURE			
Condition:	F2 - Fair	Expansion Joints:	F1 - Fair
Comments:	- Light delamin. and spalling with medium corrosion to exposed reinf. on all double tees, especially in areas where deck drains are located. - No chalking in expansion gaps in curbs. - No visible signs of expansion joints (paved over on deck).		
DECK

Condition:	F2 - Fair	Curbs:	F2 - Fair
Hand Rail:	F1 - Fair	Roadway Condition:	F2 - Fair
Approach Rail:	F1 - Fair		
Comments:	- Light scrapes, dents and rust to approach and exit rail. - No hazard markers visible - Medium horiz. cracks to deck/ curb fascia. Medium spalling to deck/ curb fascias - Medium/ wide/ vert. and horiz. cracks and medium spalling to concrete handrails and posts. - Road surface is in fairly good condition.

Overall Condition:	P1 - Poor	Requires Further Inspection:	Yes
Additional Observations:	- P1 (bearing seats, creep blocks, curtain blocks and abutment corners). - F2 (remainder) - Bridge office should re-inspect abutments, creep blocks and bearing seats.

Next Rehab. Date:	2021	Replacement Year:	2025
Antic. Rehab. Cost:	\$100	Replacement Cost:	\$850
Recommendations:	- Repair areas on abutment corners, bearing seats, creep and curtain blocks ASAP. - Chalk expansion gaps in curbs. - Repair concrete defects. - Install 4 new regulation hazard markers. - Correct shoulder erosion.
