GOVERNMENT OF NEWFOUNDLAND AND LABRADOR Department of Transportation and Infrastructure	BRIDGE INSPECTION REPORT B09012021-9	
Date: 3/3/2020	Inspected By: Chris Lyver	Category: Eng. - Engineering	
BRIDGE INFORMATION			
Site:	1-025 - POINT LANCE RIVER BRIDGE		
Route:	100-16	Overall Length:	17 m
Year Built:	1990	Est: No	Overall Width: 12 m
Year Last Rehab.:		Est: No	Roadway Width: 8.7 m
Region:	AVALON PENINSULA	Sidewalk Width:	0 m
Jurisdiction:	Provincial	Clearance to R.D. or N.W.L.:	6.7 m
Type of Structure:	04 - Rigid Frame	Max Depth of N.W.L.:	1.2 m
Purpose of Structure:	04 - Over Non-Navigable Waters		
Type of Handrail:	06 - None	Spans:	
Roadway Surface:	02 - Asphalt	<u>Span No.:</u>	<u>Length</u>
Alignment Vertical:	02 - Adequate	1	15.6
Alignment Horizontal:	02 - Adequate	2	0
Restrictions:	No	3	0
		<u>Span No.:</u>	<u>Length</u>
		4	0
		5	0
		6	0
BRIDGE PHOTOS

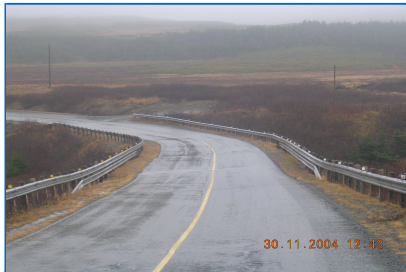
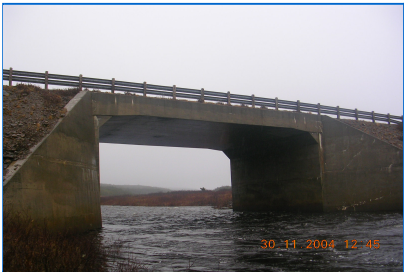
Bearing Seat:	I - Inapplicable
Comments:	- med flow lines & erosion in partially exposed frame leg & wingwall footings (assumed cond. of remaining partially submerged/buried frame leg/wingwall footings)		
SUPERSTRUCTURE			
Condition:	F2 - Fair	Expansion Joints:	I - Inapplicable
Comments:	- medium delamin./spalling/disintegration to two areas along the outside edges of east frame leg (top, upstream, mid-height, downstream) - visible flow lines, const. joints & honeycombing in wings and frame legs - light delamin./spalling atop of NW wingwall - light honeycombing/erosion along bottom of east frame leg - med erosion/honeycombing with med erosion to exposed reinf. along bott of west frame leg		
DECK

Condition:	F2 - Fair	Curbs:	I - Inapplicable
Hand Rail:	I - Inapplicable	Roadway Condition:	I - Inapplicable
Approach Rail:	F2 - Fair		
Comments:	- several areas of exposed reinf. with light rusting in deck soffit, west side (insuff. cover) - Narrow transverse cracks in deck soffit - Narrow horiz/vert. cracks with light effor. desposits in deck fascias

Next Rehab. Date:	2025	Replacement Year:	2040
Antic. Rehab. Cost:	\$30	Replacement Cost:	\$1000
Recommendations:	- repair all concrete defects - cont. to monitor erosion along bases of frame legs & wing walls
