GOVERNMENT OF NEWFOUNDLAND AND LABRADOR Department of Transportation and Infrastructure	<b>BRIDGE INSPECTION REPORT</b> <b>B09142021-1</b>	
<b>Date:</b> 2/13/2018	<b>Inspected By:</b> Chris Lyver	<b>Category:</b> Eng. - Engineering	
<b>BRIDGE INFORMATION</b>			
<b>Site:</b>	1-129 - ROCKY ISLAND POND BRIDGE - RT. 91		
<b>Route:</b>	91	<b>Overall Length:</b>	10.9 m
<b>Year Built:</b>	1964	<b>Est: Yes</b>	<b>Overall Width:</b> 5.4 m
<b>Year Last Rehab.:</b>		<b>Est: No</b>	<b>Roadway Width:</b> 5 m
<b>Region:</b>	AVALON PENINSULA	<b>Sidewalk Width:</b>	0 m
<b>Jurisdiction:</b>	Provincial	<b>Clearance to R.D. or N.W.L.:</b>	0.7 m
<b>Type of Structure:</b>	04 - Rigid Frame	<b>Max Depth of N.W.L.:</b>	0.5 m
<b>Purpose of Structure:</b>	04 - Over Non-Navigable Waters		
<b>Type of Handrail:</b>	03 - Timber Rail	<b>Spans:</b>	
<b>Roadway Surface:</b>	01 - Concrete	<u>Span No.:</u>	<u>Length</u>
<b>Alignment Vertical:</b>	02 - Adequate	1	4

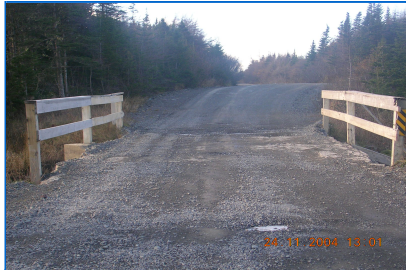
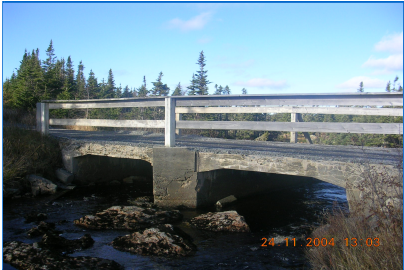
<b>SUBSTRUCTURE</b>			
<b>Condition:</b>	P3 - Poor	<b>Bearings:</b>	I - Inapplicable
		<b>Bearing Seat:</b>	I - Inapplicable
<b>Comments:</b>	- Assumed condition of buried and submerged reinf. concrete frame leg footings *Notes: Frame legs possibly poured direction onto dowelled bedrock. Pier may have asphalt impregnated board bearings (Inspection restricted due to flow)		
<b>SUPERSTRUCTURE</b>			
<b>Condition:</b>	P1 - Poor	<b>Expansion Joints:</b>	I - Inapplicable
<b>Comments:</b>	- Numerous wide vert/horiz cracks with Med effior. Deposits in pier, frame leg faces and wingwalls - Severe delamin/spalling/disintegration to corners of east frame leg - Wide cracks, medium delamin/spalling/disintegration to base of u/s pier ice wall

<b>Condition:</b>	P1 - Poor	<b>Curbs:</b>	I - Inapplicable
<b>Hand Rail:</b>	P - Poor	<b>Roadway Condition:</b>	I - Inapplicable
<b>Approach Rail:</b>	I - Inapplicable		
<b>Comments:</b>	- Very severe delamin/spalling disintegration to NW/SW deck fascias - Medium delamin/spalling/disintegration to SE/SW deck fascias, medium corrosion to exposed reinf. - Numerous wide longit/trans cracks with heavy efflor/stalactite deposits in deck soffits - Numerous wide cracks, medium-spalling and abrasion to exposed deck surface - No wooden pedestrian handrail at NE end of struct.

<b>Water Velocity:</b>	0.4 m/s	<b>Ice Problem:</b>	P - Possible Problem
<b>Water Depth:</b>	0.3 m	<b>Scour Problem:</b>	K - Known Problem
<b>Waterway:</b>	01 - Adequate	<b>Debris Problem:</b>	P - Possible Problem
<b>Comments:</b>	- Medium scour under upstream ends of frame legs and pier

<b>Next Rehab. Date:</b>	2018	<b>Replacement Year:</b>	2018
<b>Antic. Rehab. Cost:</b>	\$0	<b>Replacement Cost:</b>	\$100
<b>Recommendations:</b>	- Structure to be replaced with multi plate in 2018
