GOVERNMENT OF NEWFOUNDLAND AND LABRADOR Department of Transportation and Infrastructure	BRIDGE INSPECTION REPORT B08062021-3	
Date: 8/3/2021	Inspected By: Mike Button	Category: Office - Bridge Office	
BRIDGE INFORMATION			
Site:	1-104 - RUBY LINE OVERPASS EAST		
Route:	2	Overall Length:	34.1 m
Year Built:	1971	Est: No	Overall Width: 0 m
Year Last Rehab.:		Est: No	Roadway Width: 0 m
Region:	AVALON PENINSULA	Sidewalk Width:	0 m
Jurisdiction:	Provincial	Clearance to R.D. or N.W.L.:	0 m
Type of Structure:	04 - Rigid Frame	Max Depth of N.W.L.:	0 m
Purpose of Structure:	01 - Highway Grade Separation	Spans:	
Type of Handrail:	02 - Concrete Rail	Span No.:	Length
Roadway Surface:	02 - Asphalt	1	19.8
Alignment Vertical:	01 - Good	2	0
Alignment Horizontal:	01 - Good	3	0
Restrictions:	No	4	0
		5	0
		6	0
BRIDGE PHOTOS

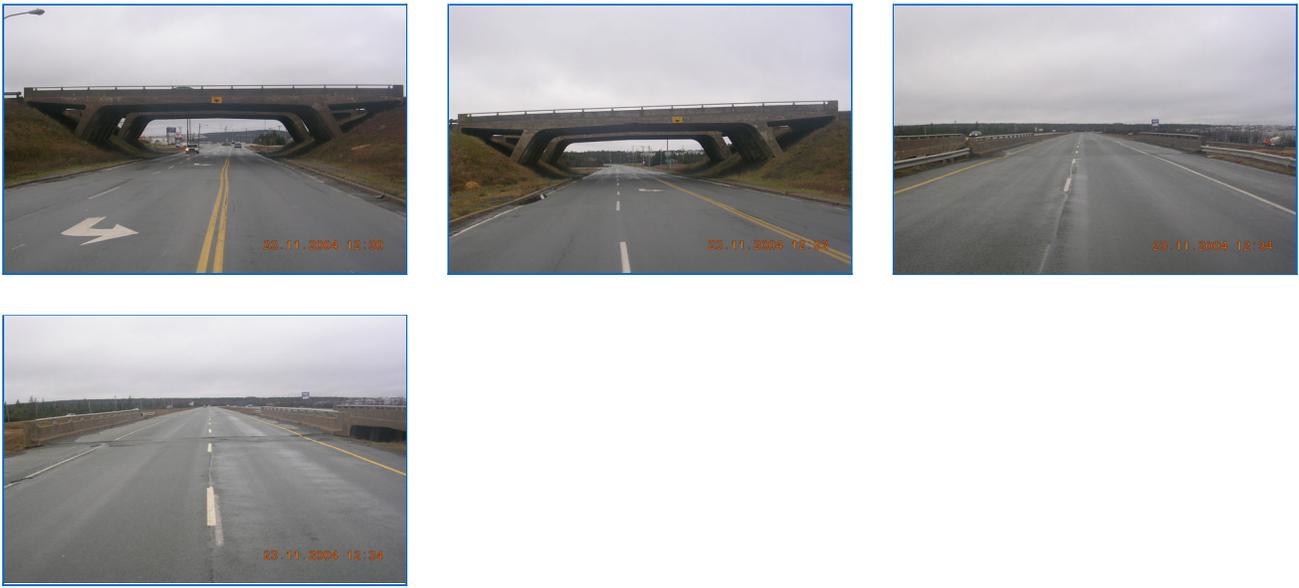
Comments:	- This is 1-104, traffic heading east on structure. - West support legs have several small spalls & cracks (F1). -

<p>East support legs, 3 legs in from south side, possible structural cracks with some medium sized spalls. 4 legs in from south side, large cracks with delamination (about to become spalls) (P3). - Southwest corner of abutment/end wall joint has a medium spall showing rebar (P3). Area in front of the abutment has a large spall/deterioration vertical rebar showing (P3). - Northwest corner of abutment/end wall joint has a medium-large spall/deterioration showing the first row of rebar. Rebar has medium corrosion (P3). - Southeast corner of abutment/end wall joint has a large spall/deterioration showing two rows of reinforcement (P1). - Northeast corner of abutment/end wall joint has a large hole (~1mx1m in plan) eroded down through the road gravels and has severely deteriorated the abutment concrete from behind. 5 vertical rows of reinforcement has been exposed. All with medium to severe corrosion (P1). - Washout also evident beneath the structure and is eroding the slope down to the support legs/piers.</p>

SUPERSTRUCTURE			
Condition:	F2 - Fair	Expansion Joints:	U - Uninspectable
Comments:	- This is 1-104, traffic heading east on structure. - Possible plug joints, paved over. - Underside of deck in excellent condition. Minor to no cracking evident (F2).		
DECK			
Condition:	P3 - Poor	Curbs:	P1 - Poor
Hand Rail:	P3 - Poor	Roadway Condition:	P1 - Poor
Approach Rail:	P1 - Poor		
Comments:	- This is 1-104, traffic heading east on structure. Asphalt in fair condition. No potholes but some cracking starting to form (F1). Exit guard rails have a post missing on the north side(P1). South side ok (F1). - Approach guard rails on the north side has a broken post. - Approach rail not up to code. Several posts missing/never installed to absorb an impact into the end blocks. Hazard markers missing (P1). - Both fascia's have many medium sized spalls to the first row of reinforcement which is severely corroded (P1). Cracking also evident with efflorescence. Cold joint exists from construction phase in the concrete. - Curbs/parapet wall on the north side has severe spalling with exposed reinforcement and severely corroded (P1).

HYDROLOGY			
Water Velocity:	n/a m/s	Ice Problem:	NA - Not Applicable
Water Depth:	n/a m	Scour Problem:	NA - Not Applicable
Waterway:	03 - Not Applicable	Debris Problem:	NA - Not Applicable
Comments:	Underpass.		
REPLACEMENT/REHABILITATION			
Next Rehab. Date:	2021	Replacement Year:	2040
Antic. Rehab. Cost:	\$250000	Replacement Cost:	\$2500000
Recommendations:	- This is 1-104, traffic heading east on structure. Fix all abutment corners ASAP. Water likely the cause of abutment corner deteriorations. Structure has no deck drains, install drains ASAP to prevent the above. Extend expansion joints out to end wall if possible. A lot of water is getting in here and causing the aforementioned issues.- Repair curb/parapet walls. - Repairs concrete defects on fascia's a support legs.		
OBSERVATIONS			
Overall Condition:	P3 - Poor	Requires Further Inspection:	No
Additional Observations:	- This is 1-104, traffic heading east on structure. Inspection hazards: Traffic. Inspect deck from shoulders and median, travelling under the structure. Watch footing on steep slopes. If deck access is needed, you need traffic control.
