GOVERNMENT OF NEWFOUNDLAND AND LABRADOR Department of Transportation and Infrastructure	BRIDGE INSPECTION REPORT B06202019-4	
Date: 6/20/2019	Inspected By: Pickett R	Category: Eng. - Engineering	
BRIDGE INFORMATION			
Site:	1-334 - RYAN'S BROOK BRIDGE CBN		
Route:	71	Overall Length:	14.4 m
Year Built:	1998	Est: No	Overall Width: 28 m
Year Last Rehab.:		Est: No	Roadway Width: 10.5 m
Region:	AVALON PENINSULA	Sidewalk Width:	0 m
Jurisdiction:	Provincial	Clearance to R.D. or N.W.L.:	3 m
Type of Structure:	04 - Rigid Frame	Max Depth of N.W.L.:	0.3 m
Purpose of Structure:	04 - Over Non-Navigable Waters	Spans:	
Type of Handrail:	06 - None	<u>Span No.:</u>	<u>Length</u>
Roadway Surface:	02 - Asphalt	1	13.3
Alignment Vertical:	01 - Good	2	0
Alignment Horizontal:	01 - Good	3	0
Restrictions:	No	4	0
		5	0
		6	0
BRIDGE PHOTOS

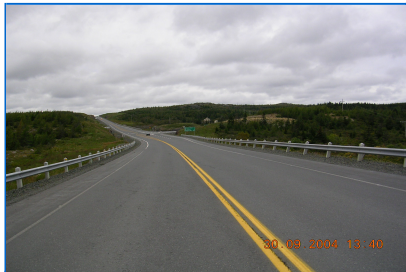
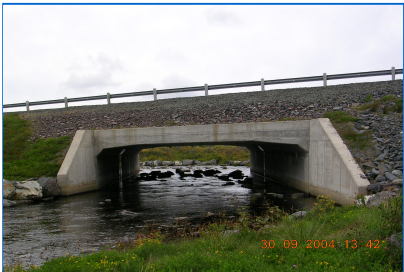
Comments:	Assumed condition of buried footing.		
SUPERSTRUCTURE			
Condition:	F2 - Fair	Expansion Joints:	I - Inapplicable
Comments:	Fair amount of wide medium cracks with heavy efflor deposits in faces of frame legs extending into soffit in places. Medium vertical construction joints at center of leg opening up with heavy efflor deposits. Alligator cracks with effloresce deposits an all wingwalls.		
DECK			
Condition:	F2 - Fair	Curbs:	I - Inapplicable

Hand Rail:	I - Inapplicable	Roadway Condition:	I - Inapplicable
Approach Rail:	F2 - Fair		
Comments:	Long construction joint along center of soffit opening up with heavy efflor deposits. Narrow medium vertical cracks with light effloresce deposits in deck facials. Narrow alligator cracks in deck fascia's approximately 2.5m fill on top of structure.
