GOVERNMENT OF NEWFOUNDLAND AND LABRADOR Department of Transportation and Infrastructure	BRIDGE INSPECTION REPORT B06142018-2	
Date: 3/6/2018	Inspected By: RH	Category: Eng. - Engineering	
BRIDGE INFORMATION			
Site:	1-154 - SALMON COVE POND		
Route:		Overall Length:	28 m
Year Built:	1960	Est: No	Overall Width: 8.9 m
Year Last Rehab.:		Est: No	Roadway Width: 0 m
Region:	AVALON PENINSULA	Sidewalk Width:	0 m
Jurisdiction:	Provincial	Clearance to R.D. or N.W.L.:	1.8 m
Type of Structure:	01 - AASH to Girder	Max Depth of N.W.L.:	0 m
Purpose of Structure:	04 - Over Non-Navigable Waters	Spans:	
Type of Handrail:	01 - Aluminum Rail	Span No.:	Length
Roadway Surface:	02 - Asphalt	1	18
Alignment Vertical:	01 - Good	2	0
Alignment Horizontal:	02 - Adequate	3	0
Restrictions:	No	Span No.:	Length
		4	0
		5	0
		6	0
BRIDGE PHOTOS

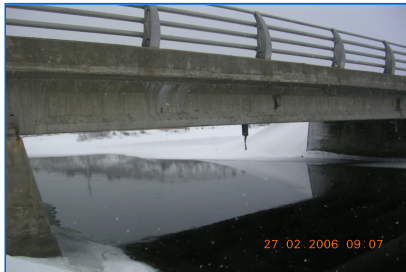
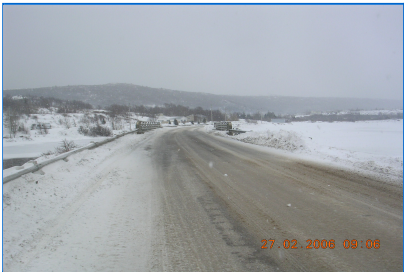
SUBSTRUCTURE			
Condition:	F1 - Fair	Bearings:	F2 - Fair
		Bearing Seat:	F2 - Fair
Comments:	- Assumed condition of buried and submerged concrete abutment footings. - Medium erosion along bases of both abutments. - Medium/ wide horiz./ vert. cracks in abutment faces with light efflor. deposits. - Severe scaling to top outside faces of NE, SE and SW wingwalls. - Medium/ severe spalling and disintegration to NW wingwall and creep block and curtain wall.

SUPERSTRUCTURE			
Condition:	F2 - Fair	Expansion Joints:	F2 - Fair
Comments:	- Light to medium spalling to ends of some girders. - Narrow horiz. cracks along flanges of exterior girders. - Light damage to south expansion joint.		
DECK

Condition:	F2 - Fair	Curbs:	F2 - Fair
Hand Rail:	F2 - Fair	Roadway Condition:	F2 - Fair
Approach Rail:	F2 - Fair		
Comments:	- Narrow transverse cracks in deck soffit and cantilevered deck soffit. - Narrow horiz. cracks in deck/ curb fascia. Numerous map cracks in exposed deck and approach slabs. - Medium abrasion and light spalling to curb faces and interior fascia. Light damage to SE curb. - Light scrapes, dents, and end caps missing on aluminum handrails.

Next Rehab. Date:	2020	Replacement Year:	2025
Antic. Rehab. Cost:	\$30	Replacement Cost:	\$1500
Recommendations:	Repair all concrete defects. - Re-inspect south expansion joint for leakage.
