GOVERNMENT OF NEWFOUNDLAND AND LABRADOR Department of Transportation and Infrastructure	BRIDGE INSPECTION REPORT B06112019-3																	
Date: 1/17/2019	Inspected By: Pickett R	Category: Eng. - Engineering																	
BRIDGE INFORMATION																			
Site:	1-260 - SHOE COVE BROOK BRIDGE																		
Route:	20	Overall Length:	8.6 m																
Year Built:	1943	Est: No	Overall Width: 11.1 m																
Year Last Rehab.:	1980	Est: No	Roadway Width: 10.3 m																
Region:	AVALON PENINSULA		Sidewalk Width: 0.4 m																
Jurisdiction:	Provincial		Clearance to R.D. or N.W.L.: 1.3 m																
Type of Structure:	04 - Rigid Frame		Max Depth of N.W.L.: 0.3 m																
Purpose of Structure:	04 - Over Non-Navigable Waters		Spans:																
Type of Handrail:	01 - Aluminum Rail

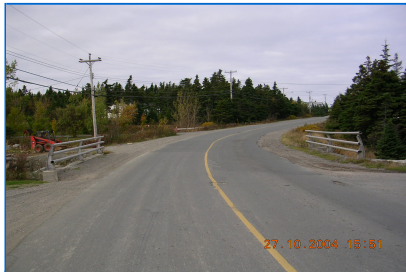
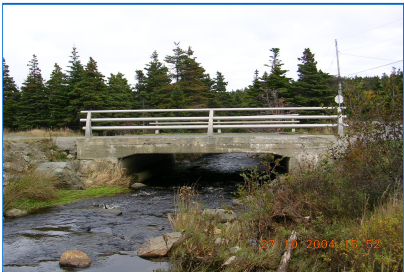
SUBSTRUCTURE																			
Condition:	P3 - Poor	Bearings:	I - Inapplicable																
		Bearing Seat:	I - Inapplicable																
Comments:	Original structure extended approximately 6m upstream. Medium erosion to frame legs.																		
SUPERSTRUCTURE																			
Condition:	P3 - Poor	Expansion Joints:	I - Inapplicable																
Comments:	Medium vertical cracking with moderate efflorance in faces of frame legs. Medium erosion/spalding to frame legs at vertical construction joints with extension. Severe delamination to North West/South West frame leg corners. Severe delamination/spalding on all wingwalls. Medium efflor deposits on deck soffit.																		
DECK																			
Condition:	P - Poor	Curbs:	P - Poor

Hand Rail:	P3 - Poor	Roadway Condition:	P - Poor
Approach Rail:	I - Inapplicable		
Comments:	Severe deuteriation to deck bottom at construction joint of extension with severe corrosion to expose rebar. Curbs have desinagration to 30% remainder medium to severe spalding. Aluminum handrail are in poor shape due to impact, including post.

Water Velocity:	0.3 m/s	Ice Problem:	N - No Problem
Water Depth:	0.4 m	Scour Problem:	N - No Problem
Waterway:	01 - Adequate	Debris Problem:	N - No Problem
Comments:	Minor slope erosion on all four corners.

Next Rehab. Date:	2019	Replacement Year:	2035
Antic. Rehab. Cost:	\$100	Replacement Cost:	\$300
Recommendations:	Repair all concrete defects. Replace damage rail and install end blocks with hazard markers.
