GOVERNMENT OF NEWFOUNDLAND AND LABRADOR Department of Transportation and Infrastructure	BRIDGE INSPECTION REPORT B06202019-3	
Date: 6/20/2019	Inspected By: Hunt R	Category: Eng. - Engineering	
BRIDGE INFORMATION			
Site:	1-030 - SOUTH RIVER BRIDGE		
Route:	70	Overall Length:	28.6 m
Year Built:	1998	Est: No	Overall Width: 10.7 m
Year Last Rehab.:		Est: No	Roadway Width: 8 m
Region:	AVALON PENINSULA	Sidewalk Width:	1.9 m
Jurisdiction:	Provincial	Clearance to R.D. or N.W.L.:	2.6 m
Type of Structure:	04 - Rigid Frame	Max Depth of N.W.L.:	2.4 m
Purpose of Structure:	03 - Over Navigable Waters	Spans:	
Type of Handrail:	01 - Aluminum Rail	<u>Span No.:</u>	<u>Length</u>
Roadway Surface:	02 - Asphalt	1	14.6
Alignment Vertical:	01 - Good	2	0
Alignment Horizontal:	01 - Good	3	0
Restrictions:	No	Span No.:	Length
		4	0
		5	0
		6	0
BRIDGE PHOTOS

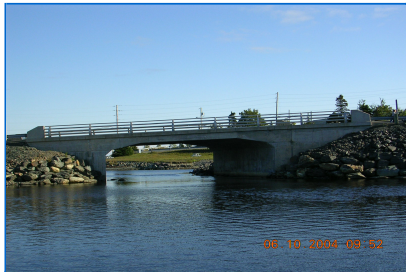
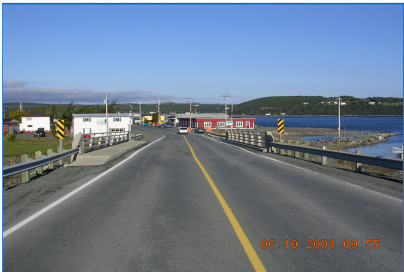
Comments:	Assumed condition of buried submerged frame leg footings.		
SUPERSTRUCTURE			
Condition:	F2 - Fair	Expansion Joints:	I - Inapplicable
Comments:	Medium vertical alligator pattern cracks in frame leg corners. Cracks extended into deck soffit. Numerous narrow alligator cracks with some medium angular crack with light efflor deposits in four wingwall.		
DECK			
Condition:	F2 - Fair	Curbs:	F2 - Fair
Hand Rail:	F2 - Fair	Roadway Condition:	F2 - Fair

Approach Rail:	F2 - Fair
Comments:	Wide vertical horizontal cracks with light efflor deposits in extension curb. Guiderail post on south end approach rail is cracked. Some cracks, rusting and some potholes in asphalt over deck and approaches. Some minor abrasion on face of sidewall on upstream end. Small to medium cracks in all four end blocks. Narrow cracks in deck soffit that extent up too frame legs.

Water Velocity:	0 m/s	Ice Problem:	N - No Problem
Water Depth:	0 m	Scour Problem:	N - No Problem
Waterway:	01 - Adequate	Debris Problem:	N - No Problem
Comments:	Water velocity and water depth are specified as tidal. Hydraulic rip rap around structure corners is in good condition. Some light erosion around corners of structure.

Next Rehab. Date:	2023	Replacement Year:	2050
Antic. Rehab. Cost:	\$50	Replacement Cost:	\$750
Recommendations:	Replace asphalt on deck and approaches. Fix settlement in wheelchair ramps. Fix broken guiderail on South approach
