GOVERNMENT OF NEWFOUNDLAND AND LABRADOR Department of Transportation and Infrastructure	BRIDGE INSPECTION REPORT B05062022-9	
Date: 4/11/2022	Inspected By: Trevor Upshall	Category: Eng. - Engineering	
BRIDGE INFORMATION			
Site:	1-108 - SPOUT BROOK BRIDGE		
Route:	10	Overall Length:	29.7 m
Year Built:	1972	Est: No	Overall Width: 11.3 m
Year Last Rehab.:		Est: No	Roadway Width: 7 m
Region:	AVALON PENINSULA		Sidewalk Width: 0.75 m
Jurisdiction:	Provincial		Clearance to R.D. or N.W.L.: 5 m
Type of Structure:	01 - AASH to Girder		Max Depth of N.W.L.: 0 m
Purpose of Structure:	04 - Over Non-Navigable Waters		Spans:
Type of Handrail:	02 - Concrete Rail		
Roadway Surface:	02 - Asphalt	Span No.:	Length
Alignment Vertical:	01 - Good	1	17.9
Alignment Horizontal:	01 - Good	2	0
Restrictions:	No	3	0
		4	0
		5	0
		6	0
BRIDGE PHOTOS

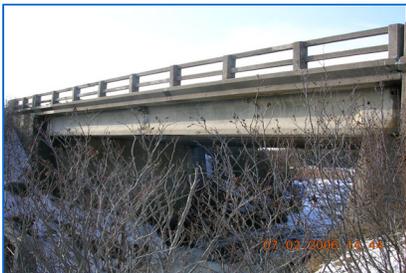
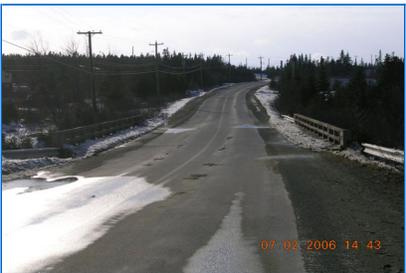
Comments:	Narrow to medium cracks with efflorescence to SE corner of footing. Medium erosion to bottom of east footing. Narrow cracks on footings, wing walls, abutment faces with light deposits of efflorescence. Assumed condition of bearing and bearing seat inspection restricted due to height.		
SUPERSTRUCTURE			
Condition:	F2 - Fair	Expansion Joints:	F1 - Fair
Comments:	Medium spalling with narrow longitudinal cracks near bearing on upstream exterior girder flange. Light delamination with light corrosion to exposed rebar on downstream exterior girder flange bottom. NE creep block narrow pattern cracks. Center creep block on east side has wide vertical cracks. Some light spalling on diaphragms. Expansion joint dams are paved over with exposed area having some deterioration and filled with debris.

DECK			
Condition:	F1 - Fair	Curbs:	P3 - Poor
Hand Rail:	G - Good	Roadway Condition:	F1 - Fair
Approach Rail:	F2 - Fair		
Comments:	Light disintegration to concrete beneath steel handrail posts. Medium spalling/abrasion with exposed rebar to NE curb. Medium erosion to SE shoulder/embankment. Upstream cantilever soffit light spalling with light corrosion to exposed rebar. Medium longitudinal cracks with light efflorescence deposits to deck soffit near end diaphragms. South curb fascia leaking efflorescence at construction joint. Light raveling of asphalt with small potholes and narrow transverse cracks near expansion joints.		
HYDROLOGY			
Water Velocity:	1.3 m/s	Ice Problem:	N - No Problem
Water Depth:	0.8 m	Scour Problem:	P - Possible Problem
Waterway:	01 - Adequate	Debris Problem:	N - No Problem
Comments:	Medium erosion/scour under west footing.		
REPLACEMENT/REHABILITATION			
Next Rehab. Date:	2026	Replacement Year:	2030
