GOVERNMENT OF NEWFOUNDLAND AND LABRADOR Department of Transportation and Infrastructure	BRIDGE INSPECTION REPORT B06082024-4	
Date: 5/22/2024	Inspected By: Trevor Upshall	Category: Eng. - Engineering	
BRIDGE INFORMATION			
Site:	1-363 - SPRINGFIELD RIVER BRIDGE		
Route:	70	Overall Length:	7 m
Year Built:	1966	Est: Yes	Overall Width: 9.1 m
Year Last Rehab.:		Est: No	Roadway Width: 7 m
Region:	AVALON PENINSULA	Sidewalk Width:	0 m
Jurisdiction:	Provincial	Clearance to R.D. or N.W.L.:	1.3 m
Type of Structure:	03 - Reinforced Concrete Beam/Slab	Max Depth of N.W.L.:	0.2 m
Purpose of Structure:	04 - Over Non-Navigable Waters	Spans:	
Type of Handrail:	02 - Concrete Rail	Span No.:	Length
Roadway Surface:	02 - Asphalt	Span No.:	Length
Alignment Vertical:	01 - Good	1	5.4
Alignment Horizontal:	01 - Good	2	0
Restrictions:	No	3	0
		4	0
		5	0
		6	0
BRIDGE PHOTOS

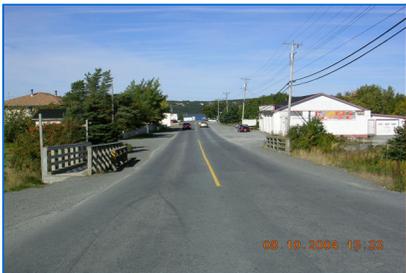
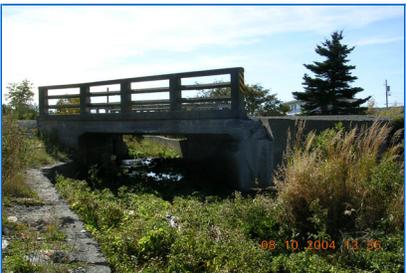
Bearing Seat:	F1 - Fair
Comments:	Assumed condition of buried reinforced concrete abutment footings. Light erosion to visible footings and bottom of abutment face. Wide vertical crack in north abutment. Light surface corrosion to exposed reinforcement on abutment faces. Severe spalling/disintegration to northeast corner of abutment/wingwall. Medium vertical/horizontal cracks with light efflorescence deposits in wingwalls and abutments. Asphalt board bearing visible along north abutment only. Numerous vertical/horizontal cracks, medium spalling with light efflorescence deposits in upstream and downstream retaining walls.		
SUPERSTRUCTURE			
Condition:	F1 - Fair	Expansion Joints:	U - Uninspectable
Comments:	No visible signs of expansion joints. Light honeycombing and medium delamination in deck soffit. Hairline to medium transverse/longitudinal cracks with medium efflorescence in deck soffit.

DECK			
Condition:	F2 - Fair	Curbs:	G - Good
Hand Rail:	G - Good	Roadway Condition:	G - Good
Approach Rail:	F2 - Fair		
Comments:	Structure underwent rehabilitation in 2022 with installation of new concrete curb and barriers walls, deck drains, curb and gutter, and guiderail for structures. Deck was resurfaced with new asphalt in 2023. Medium deformation to NW buried end. Hairline vertical/pattern cracking in new barrier wall. Medium to wide horizontal cracks, spalling, and delamination in deck fascia's.		
HYDROLOGY			
Water Velocity:	0 m/s	Ice Problem:	N - No Problem
Water Depth:	0 m	Scour Problem:	N - No Problem
Waterway:	01 - Adequate	Debris Problem:	N - No Problem
Comments:			
REPLACEMENT/REHABILITATION			
Next Rehab. Date:		Replacement Year:	2040
Antic. Rehab. Cost:	\$0	Replacement Cost:	\$0
Recommendations:			
OBSERVATIONS			
Overall Condition:	F1 - Fair	Requires Further Inspection:	No
Additional Observations:
