GOVERNMENT OF NEWFOUNDLAND AND LABRADOR Department of Transportation and Infrastructure	BRIDGE INSPECTION REPORT B06212019-1	
Date: 6/21/2019	Inspected By: lyver C	Category: Eng. - Engineering	
BRIDGE INFORMATION			
Site:	1-363 - SPRINGFIELD RIVER BRIDGE, SOUTH RIVER		
Route:	70	Overall Length:	7 m
Year Built:	1966	Est: Yes	Overall Width: 9.1 m
Year Last Rehab.:		Est: No	Roadway Width: 7 m
Region:	AVALON PENINSULA	Sidewalk Width:	0 m
Jurisdiction:	Provincial	Clearance to R.D. or N.W.L.:	1.3 m
Type of Structure:	03 - Reinforced Concrete Beam/Slab	Max Depth of N.W.L.:	0.2 m
Purpose of Structure:	04 - Over Non-Navigable Waters	Spans:	
Type of Handrail:	02 - Concrete Rail	Span No.:	Length
Roadway Surface:	02 - Asphalt	1	5.4
Alignment Vertical:	01 - Good	2	0
Alignment Horizontal:	01 - Good	3	0
Restrictions:	No	Span No.:	Length
		4	0
		5	0
		6	0
BRIDGE PHOTOS

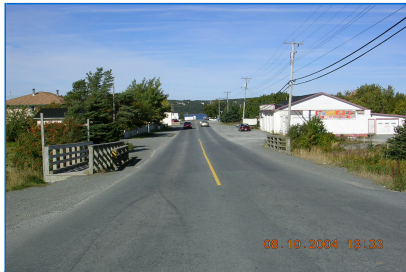
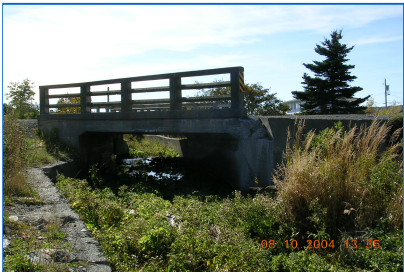
Bearing Seat:	F2 - Fair
Comments:	Assumed condition of buried or submerged reinforcement concrete abutment footings. Wide vertical cracks in center of North abutment. Medium wide vertical horizontal cracks with light efflor deposits in abutment and wingwall severe concrete spalling, disintegration to corner of North East wingwall at deck. Asphalt board bearing visible along north abutment only. Numerous vertical horizontal cracks. Medium spalling with light efflor deposits in upstream and downstream retaining walls.		
SUPERSTRUCTURE			
Condition:	F1 - Fair	Expansion Joints:	F1 - Fair
Comments:	No visible signs of expansion joints. Expansion joint gap visible at North East end.		
DECK

Condition:	P3 - Poor	Curbs:	F2 - Fair
Hand Rail:	P3 - Poor	Roadway Condition:	F2 - Fair
Approach Rail:	P1 - Poor		
Comments:	Medium light rutting with some patched potholes on deck and approaches. No hazard marker at South East end. Medium severe spalling/disintegration to deck facials especially at North East end. Guiderail(on steel posts) handrail upstream struck and tipped out. Medium spalling with wide horizontal cracks. Medium rusting to exposed reinforcement of downstream handrail.

Next Rehab. Date:	2020	Replacement Year:	2035
Antic. Rehab. Cost:	\$40	Replacement Cost:	\$400
Recommendations:	Repair all concrete defects. Replace downstream handrail and upstream guide handrail. Install approach and exit guide rail where possible.
