GOVERNMENT OF NEWFOUNDLAND AND LABRADOR Department of Transportation and Infrastructure	BRIDGE INSPECTION REPORT B08302022-8	
Date: 7/21/2022	Inspected By: M Button	Category: Office - Bridge Office	
BRIDGE INFORMATION			
Site:	1-165 - STEVE GOSES MILL BRIDGE		
Route:	81	Overall Length:	10.3 m
Year Built:	1987	Est: Yes	Overall Width: 10 m
Year Last Rehab.:		Est: No	Roadway Width: 9 m
Region:	AVALON PENINSULA	Sidewalk Width:	0.5 m
Jurisdiction:	Provincial	Clearance to R.D. or N.W.L.:	1 m
Type of Structure:	04 - Rigid Frame	Max Depth of N.W.L.:	0.5 m
Purpose of Structure:	04 - Over Non-Navigable Waters	Spans:	
Type of Handrail:	01 - Aluminum Rail	Span No.:	Length
Roadway Surface:	01 - Concrete	1	5.1
Alignment Vertical:	01 - Good	2	0
Alignment Horizontal:	01 - Good	3	0
Restrictions:	No	4	0
		5	0
		6	0
BRIDGE PHOTOS

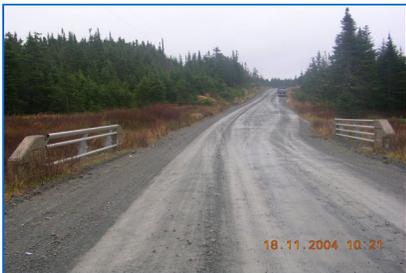
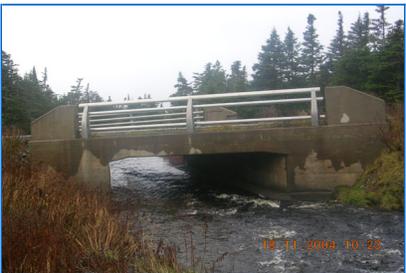
Comments:	- Both frame legs were not able to be fully inspected due to high water levels. From the river's edge, the frame legs look in fair condition with no visible issues. Northeast and southeast wingwalls look to be in fair condition, they are heavily covered by overgrowth. Northwest and southwest wingwalls have mild map cracking throughout the entire area with efflorescent leachate.		
SUPERSTRUCTURE			
Condition:	U - Uninspectable	Expansion Joints:	I - Inapplicable
Comments:	- Unable to inspect the deck soffit due to high water levels. Deck fascia's have mild cracking with efflorescent leachate.		
DECK

Condition:	F1 - Fair	Curbs:	U - Uninspectable
Hand Rail:	P1 - Poor	Roadway Condition:	F2 - Fair
Approach Rail:	I - Inapplicable		
Comments:	- The top of the deck is covered in gravel (no asphalt) but assumed to be in fair condition. Heavy vegetation growth between the curb and the deck, as well as a lot of earth buildup on and around the curbs. All end blocks look to be in fair condition, southwest end block has potential settlement or has been buried from roadway grading. Guiderails not installed. No hazard markers. Major overgrowth surrounding all the end blocks making the structure hard to see on approach. Structure rail missing rails on both sides. Structure rail also missing end caps and evidence of mild damage from snow clearing evident.		
HYDROLOGY			
Water Velocity:	1 m/s	Ice Problem:	N - No Problem
Water Depth:	1 m	Scour Problem:	P - Possible Problem
Waterway:	01 - Adequate	Debris Problem:	P - Possible Problem

Comments:	- No riprap on frame leg corners.		
REPLACEMENT/REHABILITATION			
Next Rehab. Date:	2025	Replacement Year:	2040
Antic. Rehab. Cost:	\$75,000	Replacement Cost:	\$500,000
Recommendations:	- Bridge and surrounding area needs to be cleared of all overgrowth and gravel accumulation. - Install guiderail and hazard markers. - Replace structure rail.		
OBSERVATIONS			
Overall Condition:	F1 - Fair	Requires Further Inspection:	No
Additional Observations:	- Limited inspection due to high water levels. Need to revisit later this year.
