GOVERNMENT OF NEWFOUNDLAND AND LABRADOR Department of Transportation and Infrastructure	BRIDGE INSPECTION REPORT B05242024-9	
Date: 5/24/2024	Inspected By: L Christensen	Category: Office - Bridge Office	
BRIDGE INFORMATION			
Site:	1-273 - STORE GULLY BRIDGE		
Route:	93	Overall Length:	7.9 m
Year Built:	1968	Est: Yes	Overall Width: 10.1 m
Year Last Rehab.:	1995	Est: No	Roadway Width: 6.2 m
Region:	AVALON PENINSULA		Sidewalk Width: 0 m
Jurisdiction:	Provincial	Clearance to R.D. or N.W.L.:	0.8 m
Type of Structure:	03 - Reinforced Concrete Beam/Slab		Max Depth of N.W.L.: 0.6 m
Purpose of Structure:	04 - Over Non-Navigable Waters		Spans:
Type of Handrail:	06 - None		Span No.: <u>Length</u> Span No.: <u>Length</u>
Roadway Surface:	02 - Asphalt	1	4.8 4 0
Alignment Vertical:	02 - Adequate	2	0 5 0
Alignment Horizontal:	02 - Adequate	3	0 6 0
Restrictions:	No		
BRIDGE PHOTOS

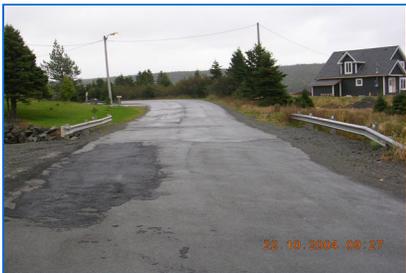
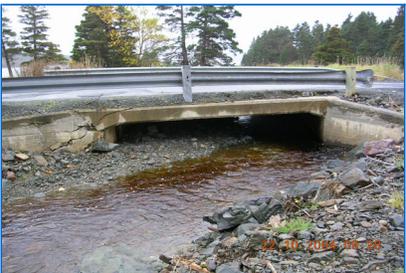
Bearing Seat:	I - Inapplicable
Comments:	Poor erosion at wing walls		
SUPERSTRUCTURE			
Condition:	P1 - Poor	Expansion Joints:	I - Inapplicable
Comments:	Half of bridge (upstream) is P1 with extreme efflorescence. The other half is P3		
DECK			
Condition:	P3 - Poor	Curbs:	I - Inapplicable
Hand Rail:	I - Inapplicable	Roadway Condition:	P3 - Poor

Approach Rail:	P3 - Poor		
Comments:			
HYDROLOGY			
Water Velocity:	0 m/s	Ice Problem:	NA - Not Applicable
Water Depth:	0 m	Scour Problem:	N - No Problem
Waterway:	01 - Adequate	Debris Problem:	N - No Problem
Comments:			
REPLACEMENT/REHABILITATION			
Next Rehab. Date:		Replacement Year:	2026
Antic. Rehab. Cost:	\$0	Replacement Cost:	\$0
Recommendations:			
OBSERVATIONS			
Overall Condition:	P1 - Poor	Requires Further Inspection:	No
Additional Observations:	Overall in P1 condition due to extreme efflorescence and erosion. Replacement recommended between 2-3 years
