GOVERNMENT OF NEWFOUNDLAND AND LABRADOR Department of Transportation and Infrastructure	BRIDGE INSPECTION REPORT B07262021-5	
Date: 7/23/2021	Inspected By: Michael Button	Category: Office - Bridge Office	
BRIDGE INFORMATION			
Site:	1-273 - STORE GULLY BRIDGE - MT. CARMEL		
Route:	93	Overall Length:	7.9 m
Year Built:	1968	Est: Yes	Overall Width: 10.1 m
Year Last Rehab.:	1995	Est: No	Roadway Width: 6.2 m
Region:	AVALON PENINSULA		Sidewalk Width: 0 m
Jurisdiction:	Provincial		Clearance to R.D. or N.W.L.: 0.8 m
Type of Structure:	03 - Reinforced Concrete Beam/Slab		Max Depth of N.W.L.: 0.6 m
Purpose of Structure:	04 - Over Non-Navigable Waters		Spans:
Type of Handrail:	06 - None		<u>Span No.:</u> <u>Length</u> <u>Span No.:</u> <u>Length</u>
Roadway Surface:	02 - Asphalt	1	4.8 4 0
Alignment Vertical:	02 - Adequate	2	0 5 0
Alignment Horizontal:	02 - Adequate	3	0 6 0
Restrictions:	No		
BRIDGE PHOTOS

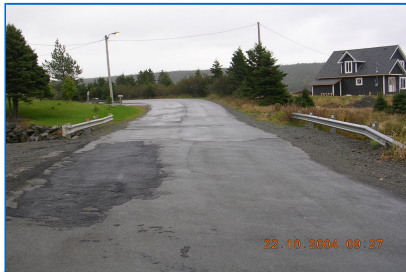
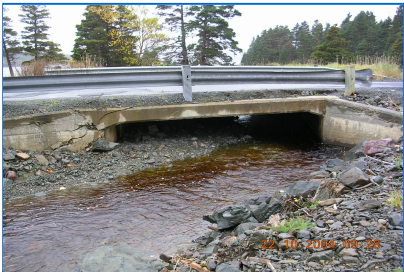
SUBSTRUCTURE			
Condition:	P3 - Poor	Bearings:	P3 - Poor
		Bearing Seat:	P3 - Poor
Comments:	- Water leaking between abutment/deck joint (Simple support connection). -Upstream side wingwalls have severe cracking with efflorescence. - Mild-medium spalling seen on wingwalls. - Upstream wingwall left hand side has a large (300-500mm) piece of concrete delaminated from the main structure.		
SUPERSTRUCTURE			
Condition:	P1 - Poor	Expansion Joints:	I - Inapplicable
Comments:	- P1 upstream - Under side of deck has medium-severe cracking with efflorescence indicating water leakage from above. - F1 downstream - Large crack with delamination along the fascia extending into the left hand side abutment.		
DECK

Condition:	P3 - Poor	Curbs:	P3 - Poor
Hand Rail:	P3 - Poor	Roadway Condition:	P3 - Poor
Approach Rail:	P3 - Poor		
Comments:	- Upstream handrail buried in road gravels. - Downstream rail bolted to structure concrete. - Asphalt in poor condition with cracking evident. - No approach guard rail or end blocks.

Overall Condition:	P3 - Poor	Requires Further Inspection:	No
Additional Observations:	- New bridge design geometry restrained by properties in area. - No approach guardrail. - Hazards of Inspection: bridge on a blind turn coming down a hill. Access to all 4 corner of structure fairly easy.

Next Rehab. Date:		Replacement Year:	2025
Antic. Rehab. Cost:	\$0	Replacement Cost:	\$1000000
Recommendations:	Replace structure within next 4 years
