GOVERNMENT OF NEWFOUNDLAND AND LABRADOR Department of Transportation and Infrastructure	BRIDGE INSPECTION REPORT B07132023-2	
Date: 6/1/2023	Inspected By: M Dalton	Category: Eng. - Engineering	
BRIDGE INFORMATION			
Site:	1-324 - TALC MINE RD OVERPASS		
Route:	60	Overall Length:	0 m
Year Built:	1996	Est: No	Overall Width: 0 m
Year Last Rehab.:		Est: No	Roadway Width: 0 m
Region:	AVALON PENINSULA	Sidewalk Width:	2 m
Jurisdiction:	Provincial	Clearance to R.D. or N.W.L.:	5.3 m
Type of Structure:	04 - Rigid Frame	Max Depth of N.W.L.:	0 m
Purpose of Structure:	01 - Highway Grade Separation	Spans:	
Type of Handrail:	01 - Aluminum Rail	Span No.:	Length
Roadway Surface:	02 - Asphalt	1	15.3
Alignment Vertical:	01 - Good	2	0
Alignment Horizontal:	01 - Good	3	0
Restrictions:	No	4	0
		5	0
		6	0
BRIDGE PHOTOS

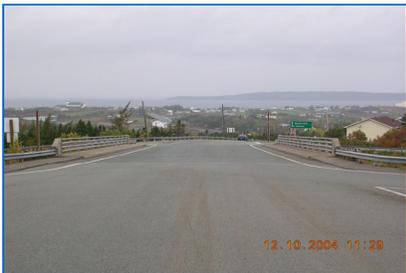
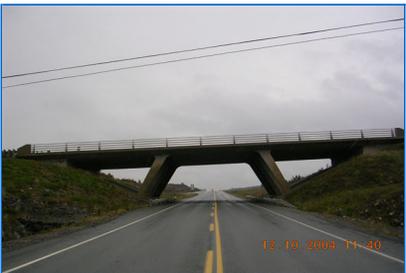
SUBSTRUCTURE			
Condition:	P3 - Poor	Bearings:	I - Inapplicable
		Bearing Seat:	I - Inapplicable
Comments:	West abutment has narrow vertical cracking and graffiti. East abutment has medium crack with stained concrete from corrosion. Wingwalls are the same condition throughout structure with narrow map cracking and light efflorescence through approach slab and deck construction joint, narrow vertical and horizontal cracks, northwest wingwall has spalling. The west and east struts have narrow to medium vertical cracking with medium to severe delamination/spalling.

SUPERSTRUCTURE			
Condition:	F1 - Fair	Expansion Joints:	I - Inapplicable
Comments:	Deck soffit has narrow vertical and map cracking with narrow longitudinal cracks traveling into abutment. Southwest deck soffit has light spall with exposed rebar with light corrosion. East deck soffit has medium longitudinal crack.

DECK			
Condition:	P3 - Poor	Curbs:	P3 - Poor
Hand Rail:	F2 - Fair	Roadway Condition:	P3 - Poor
Approach Rail:	P3 - Poor		
Comments:	Asphalt has severe potholes with exposed deck and approach slab, asphalt is raveling. Sidewalk has narrow transverse, longitudinal, and map cracking, caulking between sidewalk construction joints deteriorating. Structure rail is in fair condition, missing end cap on northwest railing. Guiderail in fair condition with a deformation on the southwest corner, wooden guiderail posts are rotting on all corners, northwest guiderail endblock shoe is missing bolts, and no hazard markers. Slope is eroded by sidewalk on all corners. Southwest curb fascia has exposed rebar with spalling concrete, and southeast curb fascia has narrow vertical crack and wide horizontal crack. North endblocks have narrow vertical transverse cracking.		
HYDROLOGY			
Water Velocity:	n/a m/s	Ice Problem:	NA - Not Applicable

Water Depth:	n/a m	Scour Problem:	NA - Not Applicable
Waterway:	03 - Not Applicable	Debris Problem:	NA - Not Applicable
Comments:			
REPLACEMENT/REHABILITATION			
Next Rehab. Date:	2025	Replacement Year:	2050
Antic. Rehab. Cost:	\$0	Replacement Cost:	\$0
Recommendations:	Repair all concrete defects, install hazard markers, replace approach/exit rail and posts, and resurface asphalt deck.		
OBSERVATIONS			
Overall Condition:	P3 - Poor	Requires Further Inspection:	No
Additional Observations:	P3 - Strut legs, exterior curb fascia, construction joint between deck and approach slab, asphalt surface, approach/exit rail and posts.
