GOVERNMENT OF NEWFOUNDLAND AND LABRADOR Department of Transportation and Infrastructure	BRIDGE INSPECTION REPORT B03122024-1	
Date: 8/25/2023	Inspected By: M Button / T Upshall	Category: Eng. - Engineering	
BRIDGE INFORMATION			
Site:	TCH-114 - HOLYROOD ACCESS OVERPASS-WESTBOUND		
Route:	1	Overall Length:	0 m
Year Built:	1991	Est: No	Overall Width: 12.35 m
Year Last Rehab.:		Est: No	Roadway Width: 10.35 m
Region:	AVALON PENINSULA		Sidewalk Width: 1 m
Jurisdiction:	Provincial		Clearance to R.D. or N.W.L.: 5.2 m
Type of Structure:	04 - Rigid Frame		Max Depth of N.W.L.: 0 m
Purpose of Structure:	01 - Highway Grade Separation		Spans:
Type of Handrail:	01 - Aluminum Rail		
Roadway Surface:	02 - Asphalt		
Alignment Vertical:	01 - Good		
Alignment Horizontal:	01 - Good		
Restrictions:	No		
BRIDGE PHOTOS			
<div style="display: flex; justify-content: space-around;">

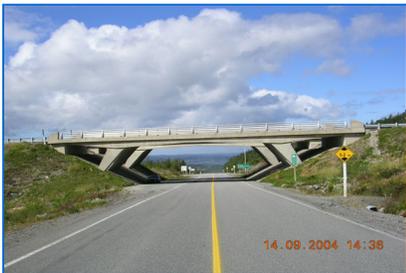
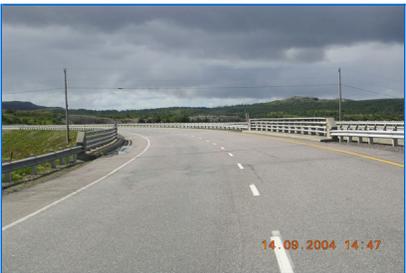
Bearing Seat:	I - Inapplicable
Comments:	Medium vertical cracks in abutment face. Medium pattern cracks with visible corroded reinforcement in wingwalls. Medium pattern cracking in all strut legs. Caulking around base of struts disintegrated. Graffiti covering east abutment face.		
SUPERSTRUCTURE			
Condition:	F2 - Fair	Expansion Joints:	I - Inapplicable
Comments:			
DECK			
Condition:	P3 - Poor	Curbs:	P3 - Poor

Hand Rail:	F2 - Fair	Roadway Condition:	P3 - Poor
Approach Rail:	P3 - Poor		
Comments:	Medium pattern cracking in deck soffit near strut legs. Very wide horizontal/vertical cracks and medium pattern cracking in end blocks. Light spalling, wide horizontal crack with light efflorescence and concrete surface stained from corroded reinforcement to North and South curb fascia. Narrow pattern cracking to north deck fascia. South deck fascia contains wide horizontal crack with narrow pattern cracking. Narrow pattern/transverse cracks with light spalls and corroded reinforcement in curb soffit. Medium abrasions along concrete curb. Severe abrasion/spall with exposed reinforcement to SW curb. Severe pot holes in asphalt exposing second matt. No structural guiderail or end shoe. Guiderail poorly attached to end blocks. Light surface corrosion to bolts securing aluminum railing to curb. Efflorescence leaking through exterior curb soffit accumulating on deck fascia.

HYDROLOGY			
Water Velocity:	n/a m/s	Ice Problem:	NA - Not Applicable
Water Depth:	n/a m	Scour Problem:	NA - Not Applicable
Waterway:	03 - Not Applicable	Debris Problem:	NA - Not Applicable
Comments:			
REPLACEMENT/REHABILITATION			
Next Rehab. Date:	2026	Replacement Year:	2040
Antic. Rehab. Cost:	\$0	Replacement Cost:	\$0
Recommendations:	Install structural guiderail. Repair concrete defects. Resurface asphalt driving surface. Caulk base of struts. Cleanup debris from erosion at SE/SW corners. Paint over graffiti.		
OBSERVATIONS			
Overall Condition:	P3 - Poor	Requires Further Inspection:	No
Additional Observations:
