GOVERNMENT OF NEWFOUNDLAND AND LABRADOR Department of Transportation and Infrastructure	<b>BRIDGE INSPECTION REPORT</b> <b>B03242024-1</b>	
<b>Date:</b> 9/26/2023	<b>Inspected By:</b> M Button / T Upshall	<b>Category:</b> Eng. - Engineering	
<b>BRIDGE INFORMATION</b>			
<b>Site:</b>	TCH-113 - TCH-RT.13 UNDERPASS WITLESS BAY LINE		
<b>Route:</b>	13	<b>Overall Length:</b>	59 m
<b>Year Built:</b>	1989	<b>Est:</b> No	<b>Overall Width:</b> 10.5 m
<b>Year Last Rehab.:</b>		<b>Est:</b> No	<b>Roadway Width:</b> 9 m
<b>Region:</b>	AVALON PENINSULA	<b>Sidewalk Width:</b>	0.75 m
<b>Jurisdiction:</b>	Provincial	<b>Clearance to R.D. or N.W.L.:</b>	6.1 m
<b>Type of Structure:</b>	05 - Pre-stressed Concrete Slab	<b>Max Depth of N.W.L.:</b>	0 m
<b>Purpose of Structure:</b>	01 - Highway Grade Separation	<b>Spans:</b>	
<b>Type of Handrail:</b>	01 - Aluminum Rail	<b>Span No.:</b>	<b>Length</b>
<b>Roadway Surface:</b>	02 - Asphalt	<b>Span No.:</b>	<b>Length</b>

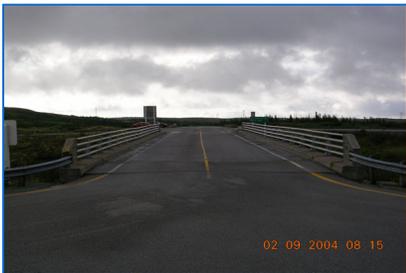
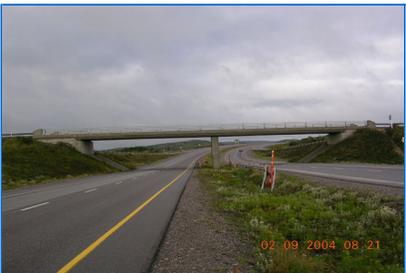
<b>SUBSTRUCTURE</b>			
<b>Condition:</b>	F1 - Fair	<b>Bearings:</b>	F1 - Fair
		<b>Bearing Seat:</b>	F1 - Fair
<b>Comments:</b>	Medium pattern cracking to center concrete piers with more severe pattern cracking near the bearings. Light surface corrosion with less than 10 percent section loss of material to bearings. Lumber/debris accumulating on bearing seat. Hairline vertical/horizontal cracks in wingwalls. Hairline pattern cracking on bearing seat. Graffiti covering abutment face.		
<b>SUPERSTRUCTURE</b>			
<b>Condition:</b>	P3 - Poor	<b>Expansion Joints:</b>	P3 - Poor
<b>Comments:</b>	Severe spalling to soffit over bearing seat. Narrow longitudinal cracking in deck soffit/fascia. Light spalling, exposed reinforcement, and narrow pattern cracking with light efflorescence deposits to deck fascia over bearing seat. Damaged SE expansion joint (snowplow abrasion) with exposed corroded steel on bridge deck. Light abrasions to expansion joint dam and seals blocked with sand. Medium spalling/delamination with wide cracks to

curb fascia at expansion joint dams. Severe deterioration to caulking around expansion joints.			
<b>DECK</b>			
<b>Condition:</b>	P3 - Poor	<b>Curbs:</b>	P3 - Poor
<b>Hand Rail:</b>	F2 - Fair	<b>Roadway Condition:</b>	P3 - Poor
<b>Approach Rail:</b>	P3 - Poor		
<b>Comments:</b>	Wide horizontal crack to interior/exterior curb fascia. Wide pattern cracking with light efflorescence deposits to NE/NW end blocks. Narrow pattern cracking to SE/SW end blocks. Narrow vertical cracks in curb above wingwalls. No structural guiderail, end shoe connections or hazard markers. Medium erosion to SE corner subgrade causing light progressive edge cracking and failure to asphalt surface. Standard guiderail attached to end blocks with only two bolts. Severe decay to guiderail posts. Severe potholes and medium raveling to asphalt surface. Asphalt deck contains areas of patching from previous potholes. Medium transverse asphalt cracks at north/south approaches. Severe damage to east median guiderail from vehicle collision.
