GOVERNMENT OF NEWFOUNDLAND AND LABRADOR Department of Transportation and Infrastructure	BRIDGE INSPECTION REPORT B04292022-2	
Date: 4/8/2022	Inspected By: M Button	Category: Office - Bridge Office	
BRIDGE INFORMATION			
Site:	1-018 - TERRY'S BROOK BRIDGE		
Route:	60	Overall Length:	6 m
Year Built:	1937	Est: No	Overall Width: 17.2 m
Year Last Rehab.:	1975	Est: Yes	Roadway Width: 10.5 m
Region:	AVALON PENINSULA		Sidewalk Width: 0 m
Jurisdiction:	Provincial	Clearance to R.D. or N.W.L.:	1.4 m
Type of Structure:	13 - Other	Max Depth of N.W.L.:	0.2 m
Purpose of Structure:	04 - Over Non-Navigable Waters		
Type of Handrail:	02 - Concrete Rail	Spans:	
Roadway Surface:	02 - Asphalt	Span No.:	Length
Alignment Vertical:	02 - Adequate	1	3.8
Alignment Horizontal:	02 - Adequate	2	0
Restrictions:	No	3	0
		4	0
		5	0
		6	0
BRIDGE PHOTOS

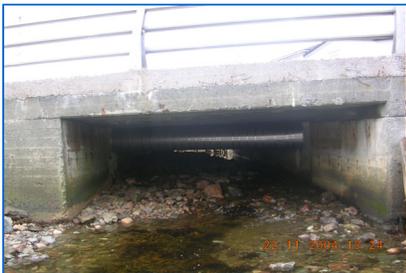
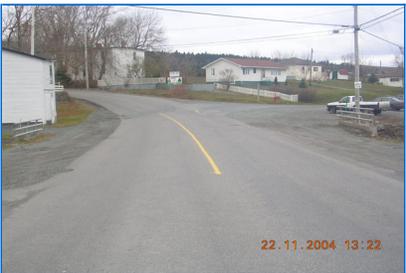
Comments:	- Rust stains from tie rods throughout abutment faces F1. – Very severe disintegration on southwest abutment corner with exposed coarse aggregate and severe efflorescence P3. – Extensions construction joints beginning to open with disintegration and moderate spalling P3. – Severe efflorescence on southeast abutment from curb P3.		
SUPERSTRUCTURE			
Condition:	P3 - Poor	Expansion Joints:	I - Inapplicable
Comments:	- Deck soffit has light to moderate honeycombing P3 in some locations. – Extension deck soffit has severe delamination and spalling P3. – South deck fascia has light erosion F1. – Moderate efflorescence on the south deck soffit close to the exterior P3. - Isolated locations on the south extension with moderate cracking and efflorescence. – Old deck fascia at an extension is disintegrated exposing reinforcement with severe corrosion, monitor for progression on future inspections, P3
