GOVERNMENT OF NEWFOUNDLAND AND LABRADOR Department of Transportation and Infrastructure	BRIDGE INSPECTION REPORT B05232024-2	
Date: 5/21/2024	Inspected By: Trevor Upshall	Category: Eng. - Engineering	
BRIDGE INFORMATION			
Site:	1-354 - THORBURN ROAD UNDERPASS		
Route:	50	Overall Length:	45.2 m
Year Built:	2002	Est: No	Overall Width: 12.25 m
Year Last Rehab.:		Est: No	Roadway Width: 9.25 m
Region:	AVALON PENINSULA		Sidewalk Width: 2 m
Jurisdiction:	Provincial		Clearance to R.D. or N.W.L.: 0 m
Type of Structure:	05 - Pre-stressed Concrete Slab		Max Depth of N.W.L.: 0 m
Purpose of Structure:	01 - Highway Grade Separation		Spans:
Type of Handrail:	01 - Aluminum Rail		Span No.: <u>Length</u> Span No.: <u>Length</u>
Roadway Surface:	02 - Asphalt		1 19.25 4 0
Alignment Vertical:	01 - Good		2 19.25 5 0
Alignment Horizontal:	01 - Good		3 0 6 0
Restrictions:	No		
BRIDGE PHOTOS			
<div style="display: flex; justify-content: space-around;">

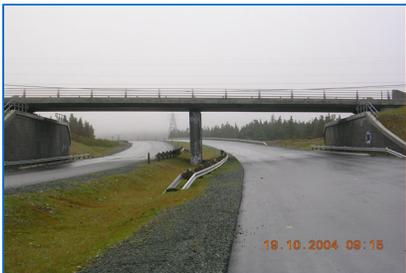
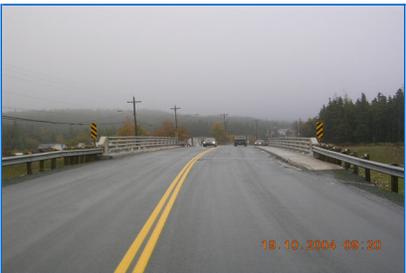
SUBSTRUCTURE			
Condition:	F1 - Fair	Bearings:	F1 - Fair
		Bearing Seat:	F2 - Fair
Comments:	Severe corrosion to steel surface of pot bearing with section loss. More severe corrosion to exterior bearings. Extensive deterioration to protective coating of bearings. Unable to inspect piers and pier bearings due to height and access restrictions. Light rust stains on concrete piers from corroded bearings. Hairline vertical cracks in abutment and ballast walls.		
SUPERSTRUCTURE			
Condition:	F2 - Fair	Expansion Joints:	F1 - Fair
Comments:	Hairline pattern cracking in sloped soffit and NE wingwall. Hairline vertical cracks in fascia. Light abrasions and corrosion to expansion joints. Rust stains on ballast wall indicating leaking expansion joints.		
DECK

Condition:	F2 - Fair	Curbs:	F2 - Fair
Hand Rail:	F1 - Fair	Roadway Condition:	F2 - Fair
Approach Rail:	F1 - Fair		
Comments:	Severe deformation to two north aluminum handrail post and top aluminum handrail. Light scraps and dents to remaining handrail. Hairline vertical cracks in east end blocks. Narrow transverse cracks in asphalt at approach slab edges. No hazard markers. Light surface corrosion to steel safety rail. Graffiti covering MSE panels, end blocks, and piers.		
HYDROLOGY			
Water Velocity:	n/a m/s	Ice Problem:	NA - Not Applicable
Water Depth:	n/a m	Scour Problem:	NA - Not Applicable
Waterway:	03 - Not Applicable	Debris Problem:	NA - Not Applicable
Comments:			
REPLACEMENT/REHABILITATION			
Next Rehab. Date:	2030	Replacement Year:	2080
Antic. Rehab. Cost:	\$0	Replacement Cost:	\$0
Recommendations:	Repair corrosion to pot bearings and apply protective coating. Install hazard markers. Repair seals on leaking expansion joints.
