GOVERNMENT OF NEWFOUNDLAND AND LABRADOR Department of Transportation and Infrastructure	BRIDGE INSPECTION REPORT B06022023-4	
Date: 5/28/2023	Inspected By: Trevor Upshall	Category: Eng. - Engineering	
BRIDGE INFORMATION			
Site:	TCH-188 - THORBURN ROAD STRUCTURE EAST		
Route:	1	Overall Length:	68.5 m
Year Built:	1998	Est: No	Overall Width: 10.6 m
Year Last Rehab.:		Est: No	Roadway Width: 9.7 m
Region:	AVALON PENINSULA	Sidewalk Width:	0 m
Jurisdiction:	Provincial	Clearance to R.D. or N.W.L.:	5.1 m
Type of Structure:	05 - Pre-stressed Concrete Slab	Max Depth of N.W.L.:	0 m
Purpose of Structure:	01 - Highway Grade Separation	Spans:	
Type of Handrail:	05 - Concrete Barrier	Span No.:	Length
Roadway Surface:	02 - Asphalt	1	15.3
Alignment Vertical:	01 - Good	2	28.3
Alignment Horizontal:	01 - Good	3	15.3
Restrictions:	No	4	0
		5	0
		6	0
BRIDGE PHOTOS

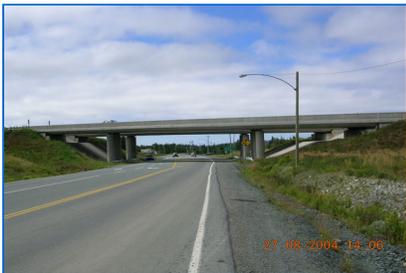
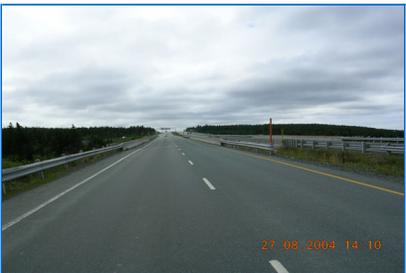
Bearing Seat:	F2 - Fair
Comments:	All wing walls in fair condition. Medium corrosion with less than 10% section loss of steel to pot bearings P3. Slider/contact plates appear in good condition. Assumed same condition of pier bearings. Pier concrete in fair condition. Protective coating peeling off all bearings. East/west concrete ballast wall and bearing seat severely stained with rust and efflorescence leaking from damaged corroded expansion joints. Both abutment faces and bearing seats in fair condition. Medium transverse cracks in sloped paving at east/west abutments. Sloped paving showing signs of settlement adjacent to NE wing wall. Concrete debris accumulating on bearing seats. Abutments painted over to cover graffiti.		
SUPERSTRUCTURE			
Condition:	F2 - Fair	Expansion Joints:	P3 - Poor
Comments:	East/west exposed expansion joint steel deformed and cracked on the road surface with the seal also being torn.

Rust staining and efflorescent deposits to abutment ballast walls caused by these damaged joints. Deck soffit remains in good condition. Hairline map cracking in concrete deck soffit directly over bearings. Light abrasions and scaling to concrete barrier walls. Fascia's on both the east and west sides have vertical hairline cracking with evidence of leakage throughout. Construction joint in the fascia has medium leaking with efflorescence on the northeast and southwest corners, and light leaking with efflorescence on the southeast and northwest corners, F1.

Condition:	F2 - Fair	Curbs:	I - Inapplicable
Hand Rail:	F2 - Fair	Roadway Condition:	F1 - Fair
Approach Rail:	F1 - Fair		
Comments:	Medium transverse settlement crack in asphalt near west approach slab. Interior barrier walls have light to medium map cracking throughout. Exterior barrier walls have narrow vertical cracks. Medium wheel track rutting to asphalt surface. Medium dents/abrasions with light surface corrosion to structural guiderail/end shoe. Evidence of rot in numerous guiderail posts. Missing hazard markers at NE/SE/SW corners.

Next Rehab. Date:	2025	Replacement Year:	2070
Antic. Rehab. Cost:	\$0	Replacement Cost:	\$0
Recommendations:	Replace expansion joints within 2 years and repair associated concrete defects. Runoff ditches to be cleaned. Install hazard markers. Replace guiderail posts.
