GOVERNMENT OF NEWFOUNDLAND AND LABRADOR Department of Transportation and Infrastructure	BRIDGE INSPECTION REPORT B06082023-7	
Date: 5/28/2023	Inspected By: M Button/S Walsh	Category: Office - Bridge Office	
BRIDGE INFORMATION			
Site:	TCH-192 - TOPSAIL RD OVERPASS EAST		
Route:	1	Overall Length:	56.7 m
Year Built:	1997	Est: No	Overall Width: 13 m
Year Last Rehab.:		Est: No	Roadway Width: 12.1 m
Region:	AVALON PENINSULA		Sidewalk Width: 0 m
Jurisdiction:	Provincial		Clearance to R.D. or N.W.L.: 5.6 m
Type of Structure:	05 - Pre-stressed Concrete Slab		Max Depth of N.W.L.: 0 m
Purpose of Structure:	01 - Highway Grade Separation		Spans:
Type of Handrail:	05 - Concrete Barrier		Span No.: <u>Length</u> Span No.: <u>Length</u>
Roadway Surface:	02 - Asphalt		1 13.5 4 0
Alignment Vertical:	01 - Good		2 22.5 5 0
Alignment Horizontal:	01 - Good		3 13.5 6 0
Restrictions:	No		
BRIDGE PHOTOS

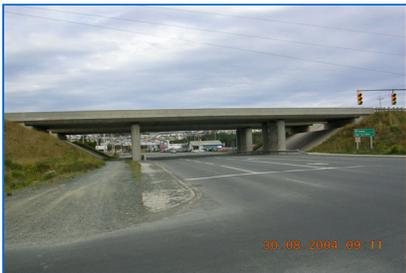
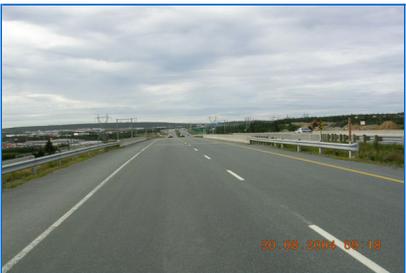
Condition:	F1 - Fair	Bearings:	F1 - Fair
		Bearing Seat:	F2 - Fair
Comments:	Medium corrosion on all bearings, P3. – Narrow map cracking on pier columns, F1. - Remainder appears to be in good condition with very minor cracks, F2.		
SUPERSTRUCTURE			
Condition:	F2 - Fair	Expansion Joints:	F1 - Fair
Comments:	Minor cracking and efflorescence visible on deck soffit near both abutments, F1. – Remainder appears to be in good condition, F2.		
DECK			
Condition:	F2 - Fair	Curbs:	I - Inapplicable

Hand Rail:	F1 - Fair	Roadway Condition:	F2 - Fair
Approach Rail:	F1 - Fair		
Comments:	Narrow map cracking on concrete barriers and end blocks, F1.		
HYDROLOGY			
Water Velocity:	n/a m/s	Ice Problem:	NA - Not Applicable
Water Depth:	n/a m	Scour Problem:	NA - Not Applicable
Waterway:	03 - Not Applicable	Debris Problem:	NA - Not Applicable
Comments:			
REPLACEMENT/REHABILITATION			
Next Rehab. Date:	2033	Replacement Year:	2067
Antic. Rehab. Cost:	\$100000	Replacement Cost:	\$0
Recommendations:			
OBSERVATIONS			
Overall Condition:	F2 - Fair	Requires Further Inspection:	No
Additional Observations:	F1 – Medium corrosion on all bearings, minor cracking with efflorescence on deck soffit at abutments. Remainder appears to be in good condition, F2.
