GOVERNMENT OF NEWFOUNDLAND AND LABRADOR Department of Transportation and Infrastructure	BRIDGE INSPECTION REPORT B06082023-6	
Date: 5/28/2023	Inspected By: M Button/S Walsh	Category: Office - Bridge Office	
BRIDGE INFORMATION			
Site:	TCH-193 - TOPSAIL RD OVERPASS WEST		
Route:	1	Overall Length:	56.7 m
Year Built:	1997	Est: No	Overall Width: 13 m
Year Last Rehab.:		Est: No	Roadway Width: 12.1 m
Region:	AVALON PENINSULA		Sidewalk Width: 0 m
Jurisdiction:	Provincial		Clearance to R.D. or N.W.L.: 5.6 m
Type of Structure:	05 - Pre-stressed Concrete Slab		Max Depth of N.W.L.: 0 m
Purpose of Structure:	01 - Highway Grade Separation		Spans:
Type of Handrail:	05 - Concrete Barrier		
Roadway Surface:	02 - Asphalt	Span No.:	Length
Alignment Vertical:	01 - Good	1	13.5
Alignment Horizontal:	01 - Good	2	22.5
Restrictions:	No	3	13.5
		4	0
		5	0
		6	0
BRIDGE PHOTOS

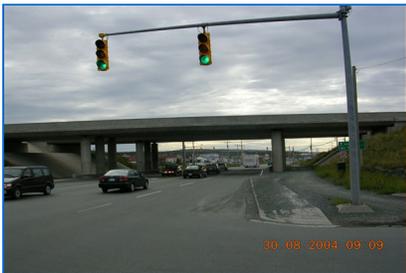
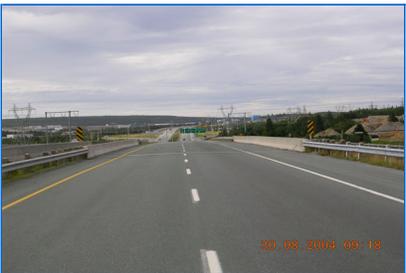
Bearing Seat:	F2 - Fair
Comments:	Severe corrosion on all bearings, P3. - Narrow map cracking on pier columns, medium map cracking on the south center pier column, F1. - Remainder appears to be in good condition with very minor cracks, F2.		
SUPERSTRUCTURE			
Condition:	F2 - Fair	Expansion Joints:	F1 - Fair
Comments:	Minor cracking and efflorescence visible on deck soffit near both abutments, P3. - Remainder appears to be in good condition, F2.		
DECK			
Condition:	F2 - Fair	Curbs:	I - Inapplicable

Hand Rail:	F1 - Fair	Roadway Condition:	F2 - Fair
Approach Rail:	F1 - Fair		
Comments:	Narrow map cracking on concrete barriers and end blocks, F1. – Minor washout on southwest end of approach, F1.		
HYDROLOGY			
Water Velocity:	n/a m/s	Ice Problem:	NA - Not Applicable
Water Depth:	n/a m	Scour Problem:	NA - Not Applicable
Waterway:	03 - Not Applicable	Debris Problem:	NA - Not Applicable
Comments:			
REPLACEMENT/REHABILITATION			
Next Rehab. Date:	2033	Replacement Year:	2067
Antic. Rehab. Cost:	\$100000	Replacement Cost:	\$0
Recommendations:			
OBSERVATIONS			
Overall Condition:	F2 - Fair	Requires Further Inspection:	No
Additional Observations:	P3 – Severe corrosion on all bearings, minor cracking with efflorescence on deck soffit at abutments. Remainder appears to be in good condition, F2.
