GOVERNMENT OF NEWFOUNDLAND AND LABRADOR Department of Transportation and Infrastructure	BRIDGE INSPECTION REPORT B03212024-1	
Date: 9/6/2023	Inspected By: M Button / T Upshall	Category: Eng. - Engineering	
BRIDGE INFORMATION			
Site:	1-074 - TORS COVE POND SPILLWAY BRIDGE & CULVERT		
Route:	10	Overall Length:	21.6 m
Year Built:	1966	Est: Yes	Overall Width: 11.2 m
Year Last Rehab.:	2000	Est: No	Roadway Width: 7.1 m
Region:	AVALON PENINSULA		Sidewalk Width: 0 m
Jurisdiction:	Provincial		Clearance to R.D. or N.W.L.: 3.3 m
Type of Structure:	04 - Rigid Frame		Max Depth of N.W.L.: 0.2 m
Purpose of Structure:	04 - Over Non-Navigable Waters		Spans:
Type of Handrail:	06 - None		Span No.: Length Span No.: Length
Roadway Surface:	02 - Asphalt		1 4.4 4 0
Alignment Vertical:	01 - Good		2 0 5 0
Alignment Horizontal:	01 - Good		3 0 6 0
Restrictions:	No		
BRIDGE PHOTOS			
<div style="display: flex; justify-content: space-around;">

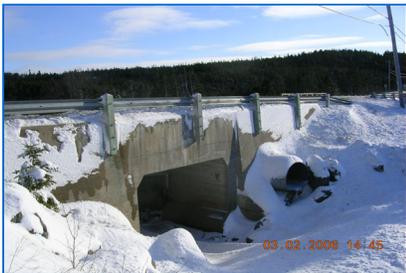
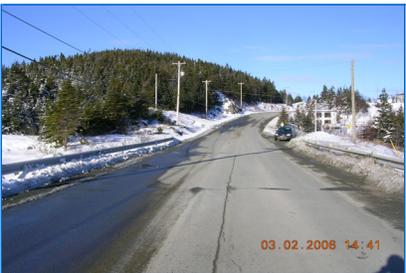
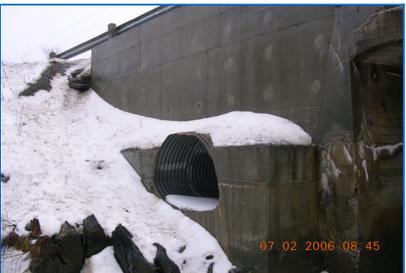
SUBSTRUCTURE			
Condition:	P3 - Poor	Bearings:	I - Inapplicable
		Bearing Seat:	I - Inapplicable
Comments:	Medium vertical/horizontal cracks with light honeycombing to upstream wingwalls. Severe scour/erosion under original frame leg footings. Medium erosion along faces of upstream extension footings. Heavy deposits of efflorescence on original frame legs.		
SUPERSTRUCTURE			
Condition:	P1 - Poor	Expansion Joints:	I - Inapplicable
Comments:	Severe spalling, delamination, and disintegration with severe corrosion (section loss) to exposed reinforcement beam and rebar on original deck edges and fascia. Severe disintegration, spalling with severe rusting to exposed reinforcement to upstream deck fascia on extensions. Medium spalling delamination, and narrow to wide longitudinal/transverse cracks in original deck soffit leaking efflorescence. Narrow cracks in deck soffit on extensions. Numerous wide horizontal/vertical cracks in faces of original frame legs leaking efflorescence. Narrow

horizontal/vertical cracks in faces of frame leg extensions. Severe delamination/spalling/disintegration to downstream exterior face of frame legs.			
DECK			
Condition:	P1 - Poor	Curbs:	I - Inapplicable
Hand Rail:	P1 - Poor	Roadway Condition:	P3 - Poor
Approach Rail:	F1 - Fair		
Comments:	Numerous medium to wide longitudinal/transverse cracks, medium potholes in Route 10 asphalt surface. Guiderail installed as safety rail needs to be raised to avoid falling hazard. Adjacent culvert contains light surface corrosion to bolts, medium deformations, medium corrosion to bottom of barrel, and couplers opening up around joins where backfill is visible.		
HYDROLOGY			
Water Velocity:	0 m/s	Ice Problem:	N - No Problem
Water Depth:	0 m	Scour Problem:	K - Known Problem
Waterway:	01 - Adequate	Debris Problem:	N - No Problem
Comments:			
REPLACEMENT/REHABILITATION			
Next Rehab. Date:	2024	Replacement Year:	2025
Antic. Rehab. Cost:	\$0	Replacement Cost:	\$0

Recommendations:	Repair concrete defects (spalling, scour, erosion, cracks, and delamination). Resurface asphalt on Route 10. Replace standard guiderail on new posts. Replace adjacent culvert. Install new safety handrail.		
OBSERVATIONS			
Overall Condition:	P1 - Poor	Requires Further Inspection:	Yes
Additional Observations:	P1 – Original Structure. F1 – Extensions. Bridge office should re-inspect original rigid frame structure.
