GOVERNMENT OF NEWFOUNDLAND AND LABRADOR Department of Transportation and Infrastructure	BRIDGE INSPECTION REPORT B05272022-10	
Date: 4/18/2022	Inspected By: Trevor Upshall	Category: Eng. - Engineering	
BRIDGE INFORMATION			
Site:	1-160 - PICCO'S BROOK BRIDGE		
Route:	20	Overall Length:	16.6 m
Year Built:	1989	Est: No	Overall Width: 9.7 m
Year Last Rehab.:		Est: No	Roadway Width: 6.7 m
Region:	AVALON PENINSULA		Sidewalk Width: 1.6 m
Jurisdiction:	Provincial		Clearance to R.D. or N.W.L.: 0.9 m
Type of Structure:	03 - Reinforced Concrete Beam/Slab		Max Depth of N.W.L.: 0.8 m
Purpose of Structure:	04 - Over Non-Navigable Waters	Spans:	
Type of Handrail:	01 - Aluminum Rail	Span No.:	Length
Roadway Surface:	02 - Asphalt	Span No.:	Length
Alignment Vertical:	01 - Good	1	7.4
Alignment Horizontal:	02 - Adequate	2	0
Restrictions:	No	3	0
		4	0
		5	0
		6	0
BRIDGE PHOTOS

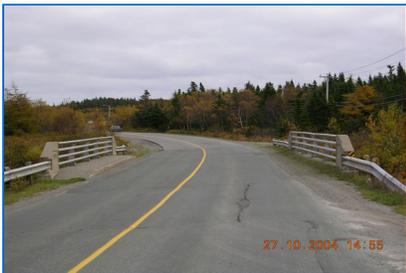
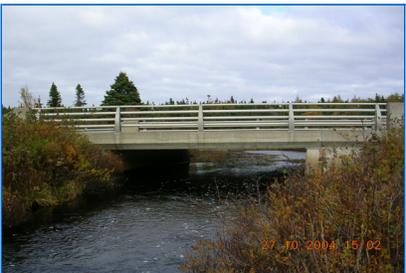
Bearing Seat:	F2 - Fair
Comments:	Assumed condition of reinforced concrete abutment footings. Light erosion along bottom of abutment faces. Narrow vertical cracks in abutment faces. Medium horizontal/vertical cracks with medium efflorescence in faces of wingwalls.		
SUPERSTRUCTURE			
Condition:	F2 - Fair	Expansion Joints:	F2 - Fair
Comments:	Narrow-medium map cracks with light abrasion to all four end blocks. Very severe shear abrasion with exposed rebar to NE end block.		
DECK

Condition:	F2 - Fair	Curbs:	F2 - Fair
Hand Rail:	F2 - Fair	Roadway Condition:	F1 - Fair
Approach Rail:	F1 - Fair		
Comments:	Narrow longitudinal cracks in deck soffit. Wide horizontal cracks near expansion joint fascia. Narrow map cracks with vertical/horizontal cracks in deck curb fascia and curb over wingwalls. Medium dents/abrasion to upstream aluminum handrail. Medium abrasion and wide vertical cracks to sidewalk surface and interior curb fascia. Buried ends damaged at NE,SE,SW corners. No hazard markers. Medium transverse cracking in asphalt along approach slab edges. Medium potholes on deck with some areas patched. Sidewalks/curbs covered in sand/debris.		
HYDROLOGY			
Water Velocity:	0.3 m/s	Ice Problem:	N - No Problem
Water Depth:	0.7 m	Scour Problem:	N - No Problem
Waterway:	01 - Adequate	Debris Problem:	N - No Problem
Comments:			
REPLACEMENT/REHABILITATION			
Next Rehab. Date:	2024	Replacement Year:	2040

Antic. Rehab. Cost:	\$60,000.00	Replacement Cost:	\$800,000.00
Recommendations:	Install hazard markers, install new buried ends at approaches, clean sand from curbs, repair asphalt deck, repair NE end block, repair aluminum handrails.		
OBSERVATIONS			
Overall Condition:	F2 - Fair	Requires Further Inspection:	No
Additional Observations:
